PROJECT SHEET

BILOELA RESERVOIR REMEDIATION

Client: Banana Shire Council

BILOELA 9ML RESERVOIR

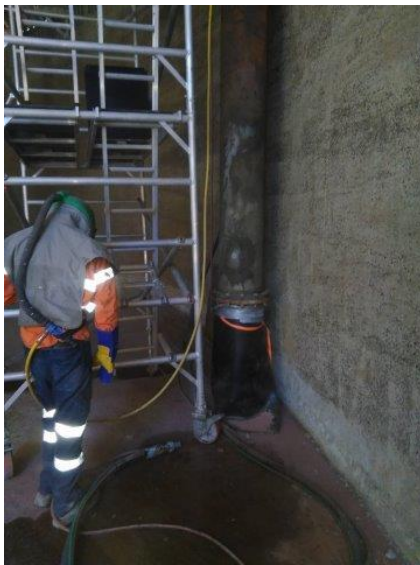
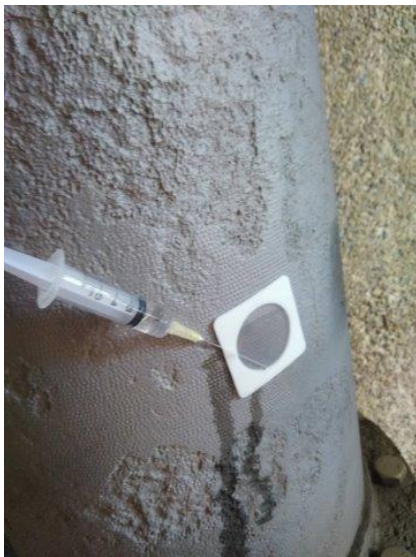
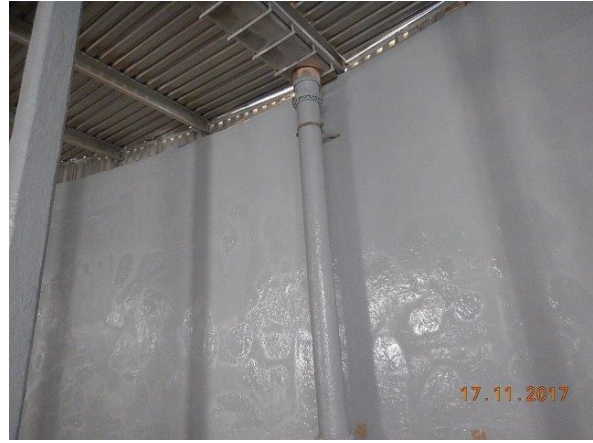
Overflow Pipe Coating

The overflow pipe was severely corroded and required a new epoxy coat of AS4020. The steel was first sandblasted and tested for salts, blast profile and whether it met the Class 2.5 Standard. It then received three coats of a high-solids epoxy and was sprayed with polyurea.

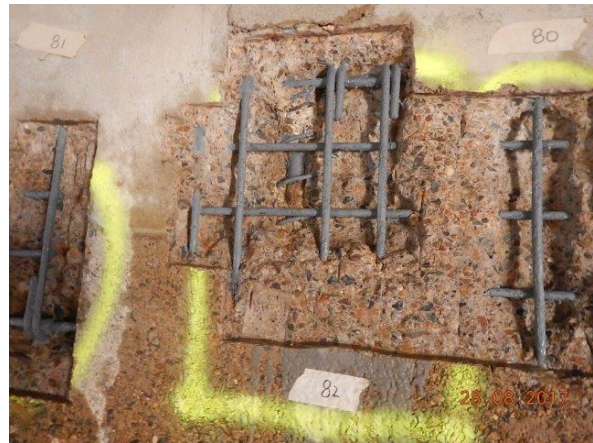
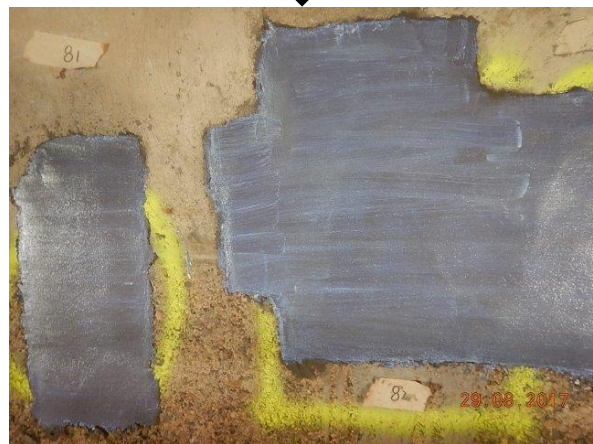
Wall concrete repairs

The defects were marked out, depth of steel determined, and the poor concrete removed. The steel was then coated with a zinc-rich coating and the defects repaired with a high strength cementitious compound. Where required, old reinforcing was replaced.

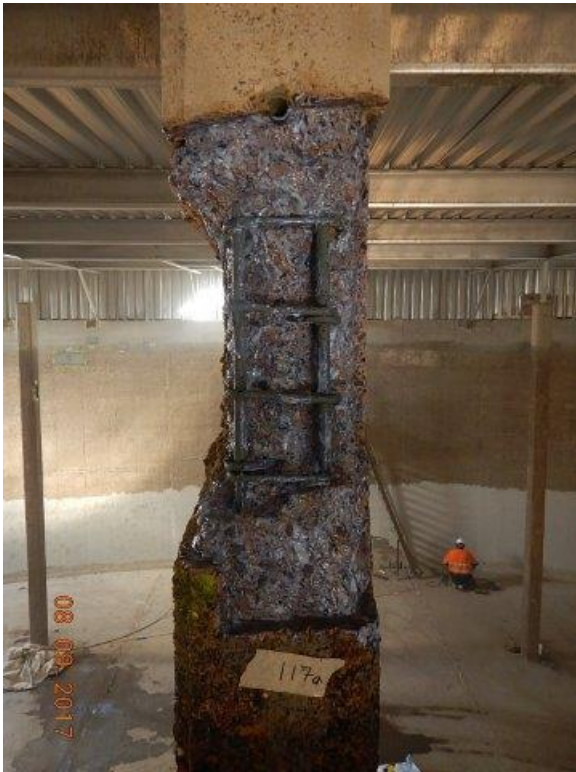
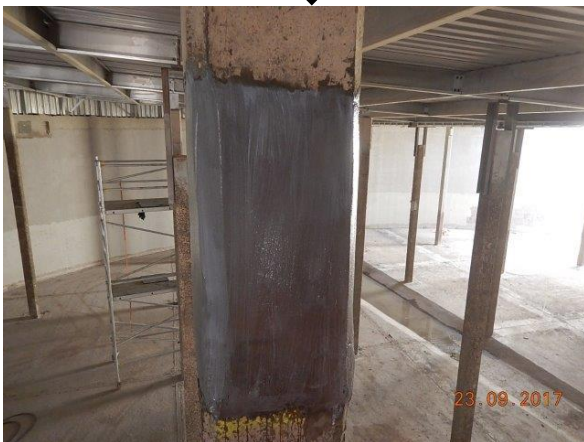
Column Concrete Repairs

The majority of the 69 columns required repair. Many were in such a poor state that the repairs had to be staged to avoid complete failure.

As with the wall repairs, the location of the existing reinforcing was identified using a concrete scanner in order to reduce the risk of damaging any bars during the cutting. The poor concrete was then removed and repaired with a cementitious compound.

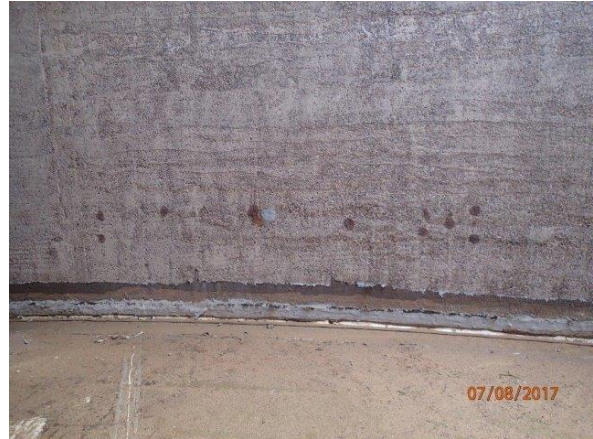
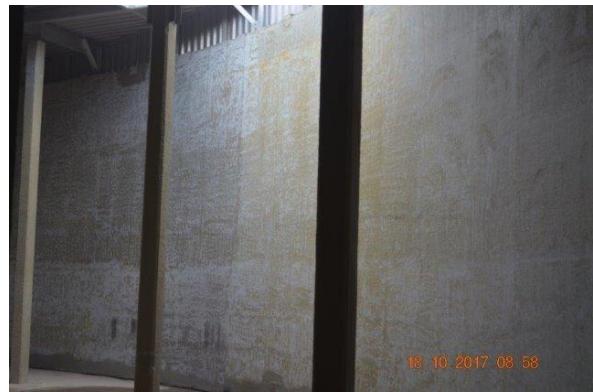
Wall Epoxy Rendering

A major challenge in applying the waterproofing membrane was the poor condition of the concrete surface. The water had etched into the concrete over time, exposing the aggregate and leaving an uneven surface. The surface was too rough to apply the membrane and needed to be levelled. Epoxy Solutions resolved this by using an AS4020 approved epoxy feathering coat, applied directly to the etched surface. This was later primed and coated with a polyurea membrane.

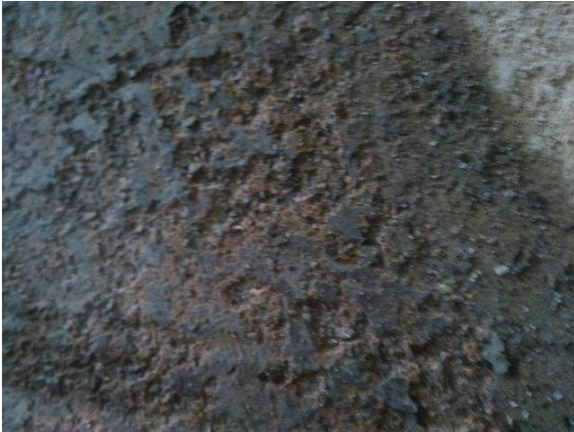
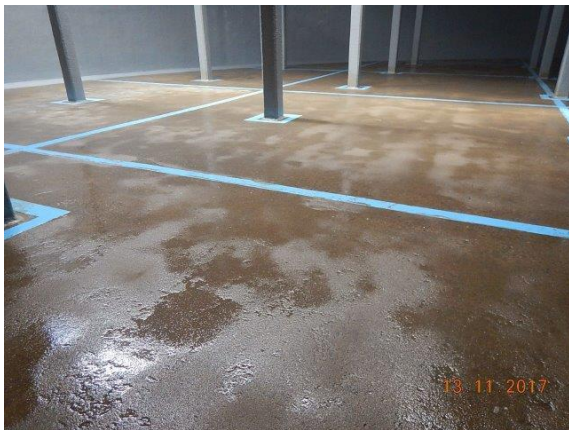
Floor Screeding

The floor proved to be challenging as it was etched, and also coated with a flexible waterproofing membrane that had failed in many locations. As grinding was tedious, Epoxy Solutions derived a system to remove the old membrane and remaining surface laitance. An epoxy screed was then applied to even out the surface to prepare it for the polyurea membrane.

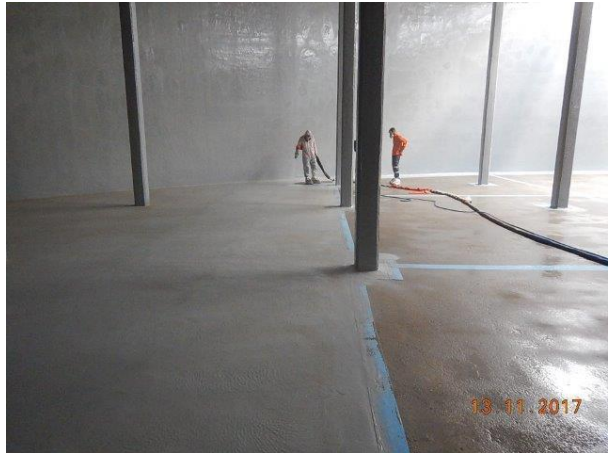
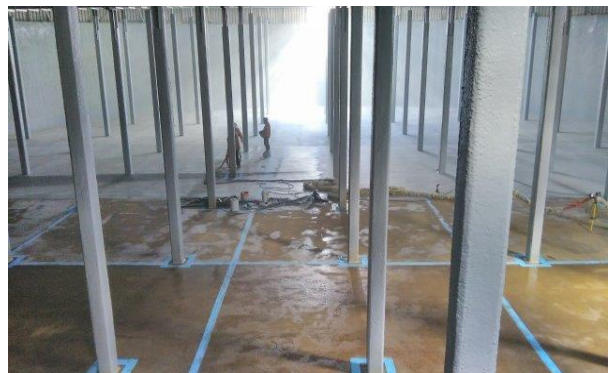
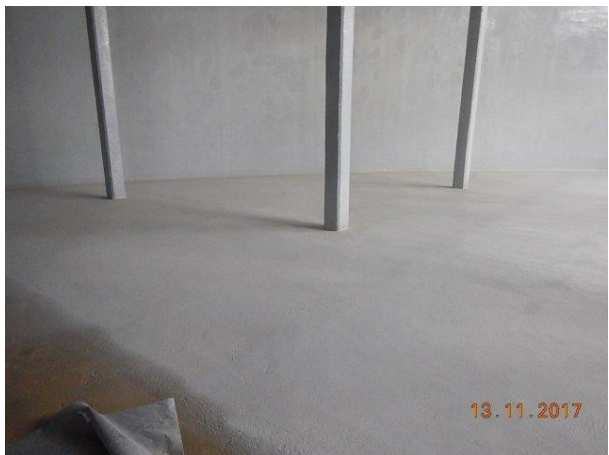
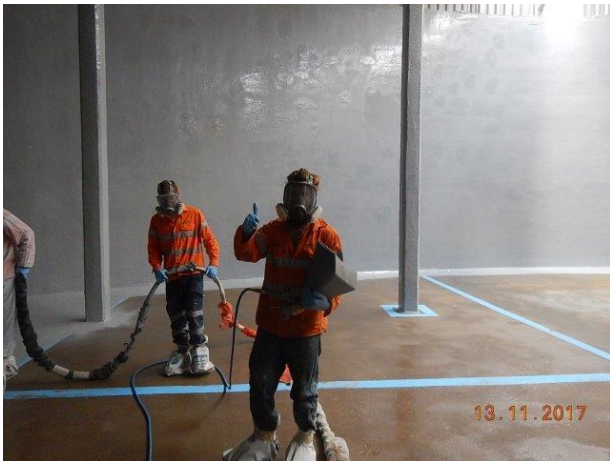
Photos: Polyurea membrane application and testing

Once the faring coat was applied to the entire surface, a 2.5mm polyurea membrane was applied. Extensive testing ensured a watertight seal was achieved.
