BILOELA RESERVOIR

PROJECT SUMMARY

Client: Banana Shire Council

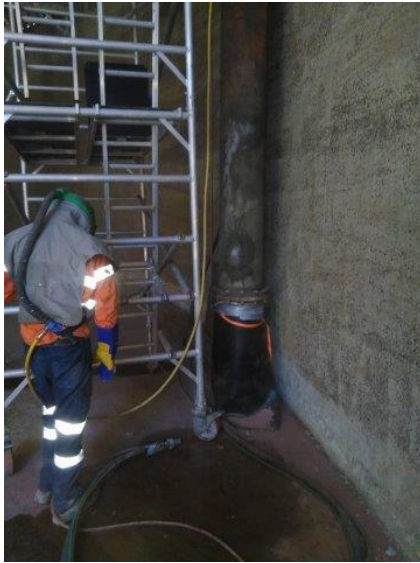
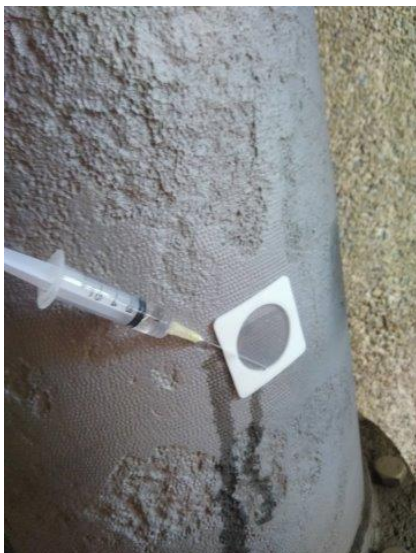
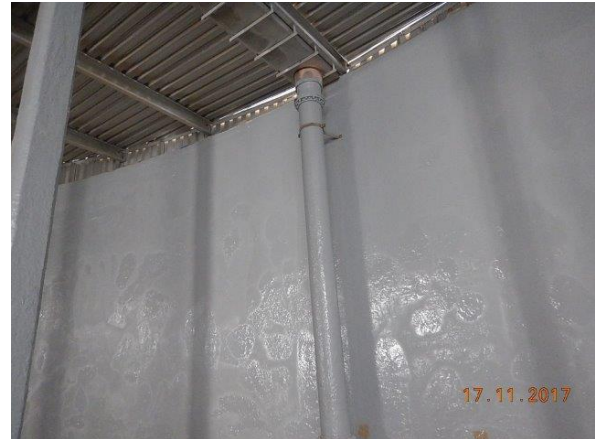
Overflow pipe coating

The overflow pipe was severely corroded and required a new epoxy coat. An AS4020 epoxy coating was applied in three coats. The steel was first abrasive blasted and tested for salts, blast profile and whether it met the class 2.5 standard. After this it received 3 coats of a high solids epoxy and sprayed with polyurea.

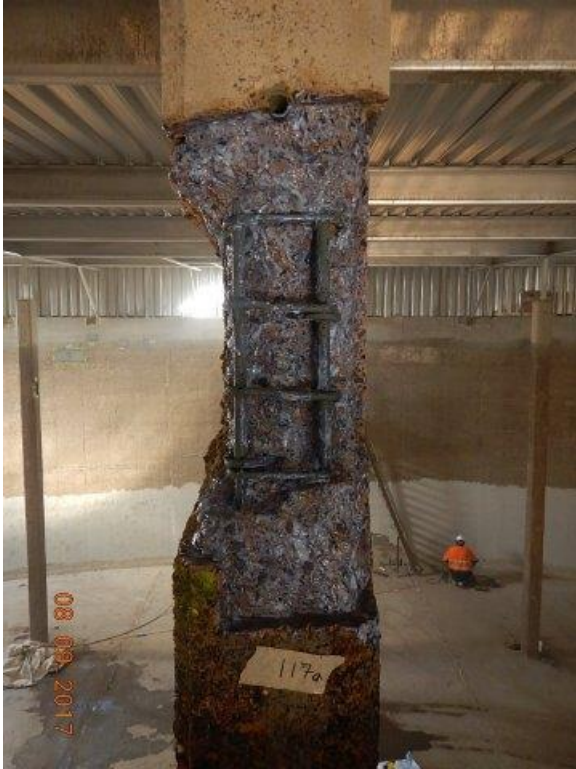
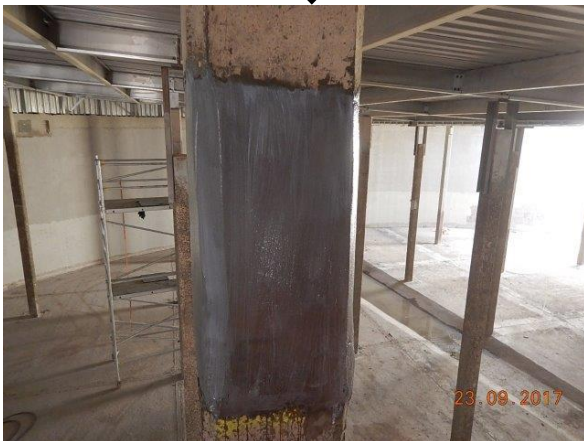
Column concrete repairs

Majority of the 69 columns required repair. Many of the columns were in such a poor state that the repairs had to be staged to avoid complete failure.

As with the wall repairs, the location of the reinforcing was identified prior to any cutting. The poor concrete was then removed and repaired with a cementitious compound.

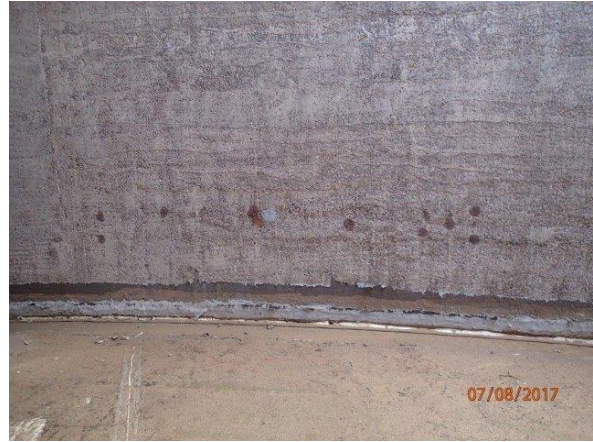
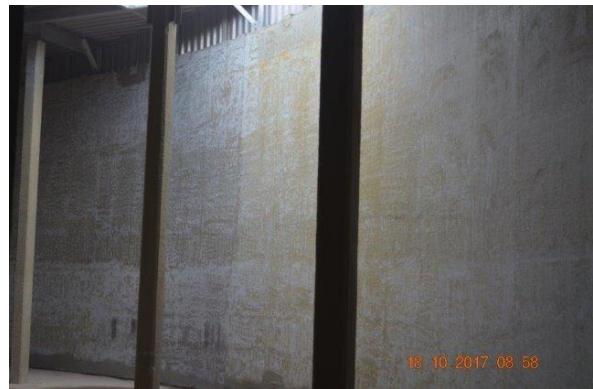
Wall Epoxy Rendering

A major challenge in applying the waterproofing membrane, was the condition of the poor condition of the concrete surface. The water had etched into the concrete overtime, exposing the aggregate and leaving a very uneven surface. The surface was too rough to apply the membrane and

needed to be smothered. To do this we used an AS4020 approved epoxy feathering coat, which was applied directly to the etched surface. This was then later primed and coated with a polyurea membrane.

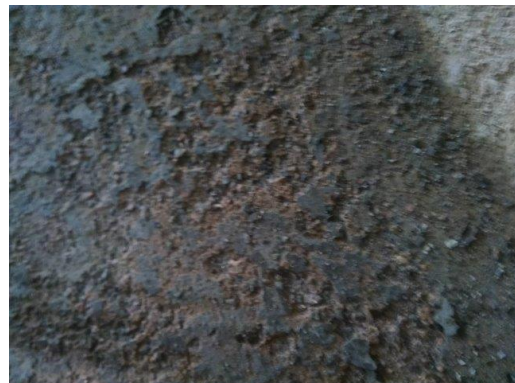
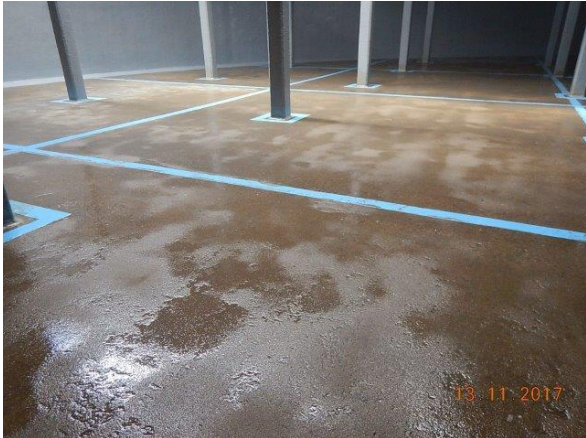
Floor screeding

The floor proved to be challenging as it was also etched, but also coated with a flexible water proofing membrane which had failed in many locations. As grinding was tedious, Epoxy Solutions derived a system to remove the old membrane and remaining surface laitance. An epoxy screed was then flatted off the surface and prepare it for the polyurea membrane.
