# DYNACIV PTY LTD

## Deep Crack Injection

A 28 metre long, post tensioned beam was constructed to support high loads above moving traffic. The beam is supporting the roof structure of the cut and cover tunnel at the Eastern side of the Legacy Way Tunnel.

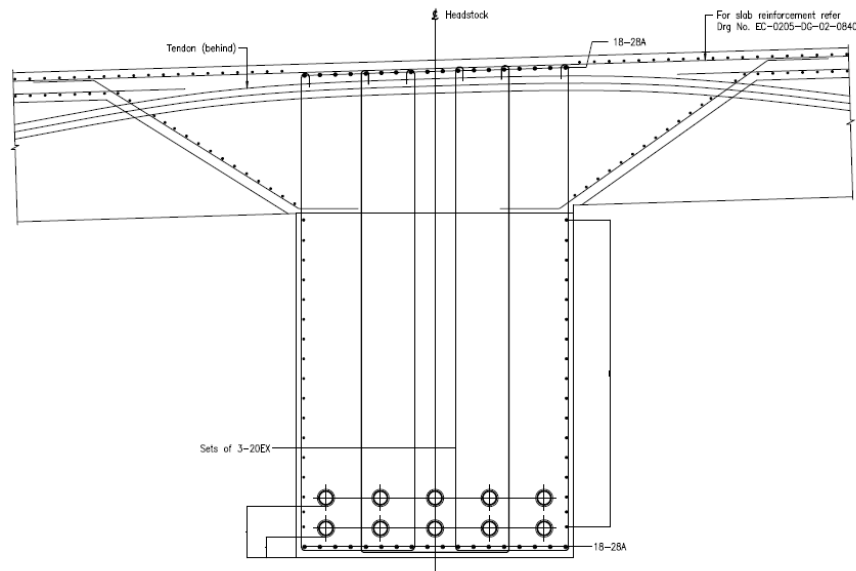
The beam is 2.8 metres wide, with an average height of approximately 3.5 metres. The large beam has 10 ducts of 135 mm running longitudinally through the beam. These ducts carry the high strength tension cables that will be used to stress the beam once it has reached full strength. A section through the beam is shown below.

**SECTION THROUGH POST-TENTIONED BEAM SHOWING TENSION DUCTS**

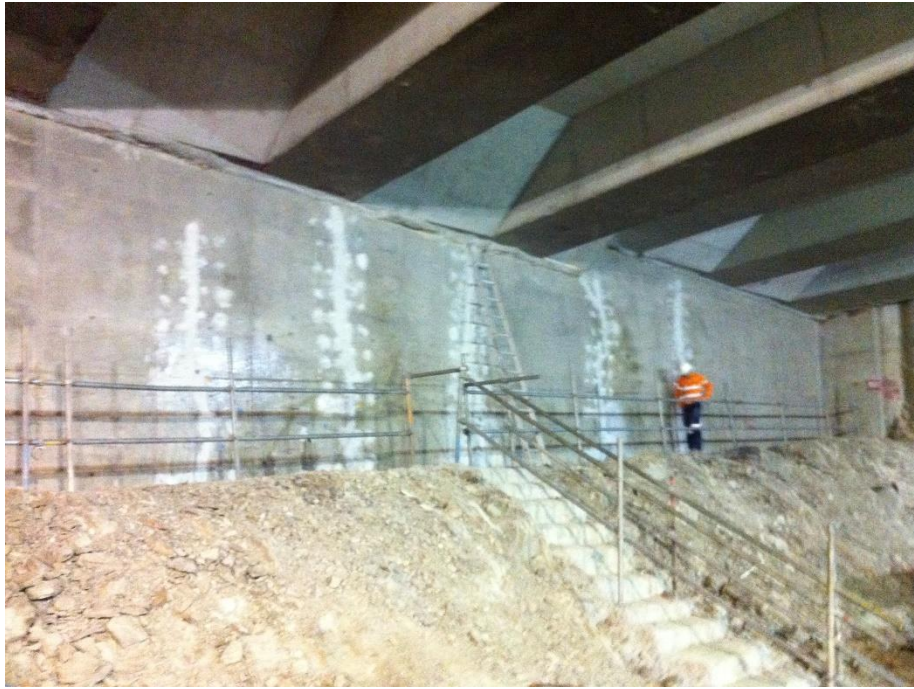
The entire beam was cast in a single pour. This mass of concrete would have generated much heat. This, along with the behaviour of the high strength concrete blend, caused the beam to crack horizontally and vertically. The cracks varied in size, however all cracks greater than 0.2 mm required repair. After a thorough investigation by the engineers, 5 cracks were identified for repair.

The photo below shows the north side of the beam with the 5 verticle cracks

**NORTH SIDE OF THE BEAM SHOWING THE FIVE CRACKS**

Dynaciv proposed a high-pressure crack repair system using the CHEMRITE® CILV Epoxy. This blend of epoxies is specifically made to achieve high strength, whilst still maintaining a good pot life at a very low viscosity. The repair proposal comprised of low-pressure injection around the duct (it was thought that the low viscosity CHEMRITE® CILV may be forced into the duct if a high-pressure system was used). To ensure coverage across the whole beam, Dynaciv proposed a system where 1.6 metre holes would be drilled into the beam at predetermined angles to intersect the crack deep within the beam. This was done at regular intervals to better the chances of penetration. Dynaciv's proposal was accepted.

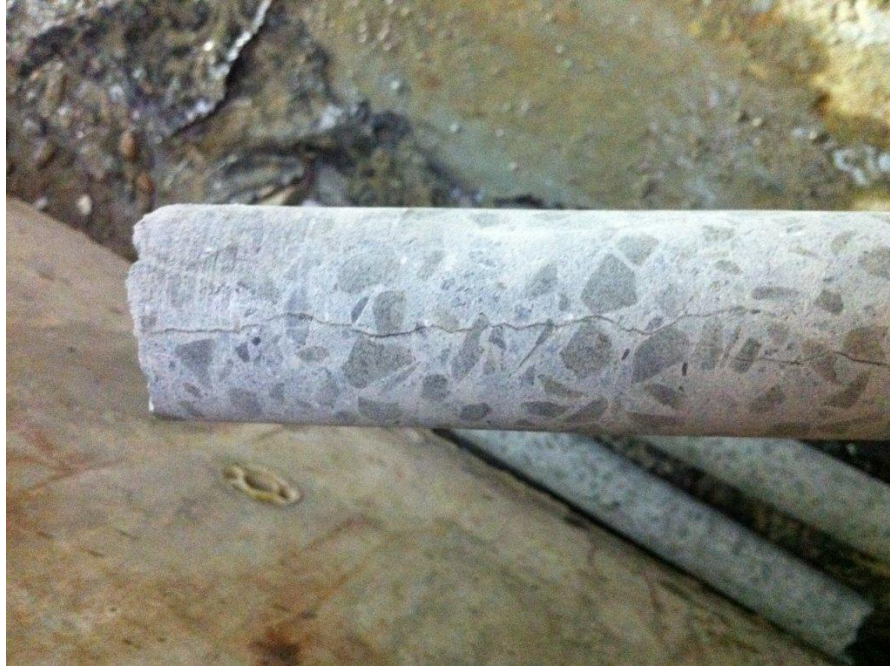
After 7 days, cores were taken to confirm penetration. Approximately 20 cores were taken across the five cracks. Many of the cores were 1000mm deep, thus confirming deep penetration. All cores tested yielded positive results – a great win for the client and Dynaciv.

**SHOWING DEEP END OF A 1000 MM CORE**
