# PROJECT SHEET

## HERBERT RIVER RAIL BRIDGE STRENGTHENING

### HERBERT RIVER RAIL BRIDGE

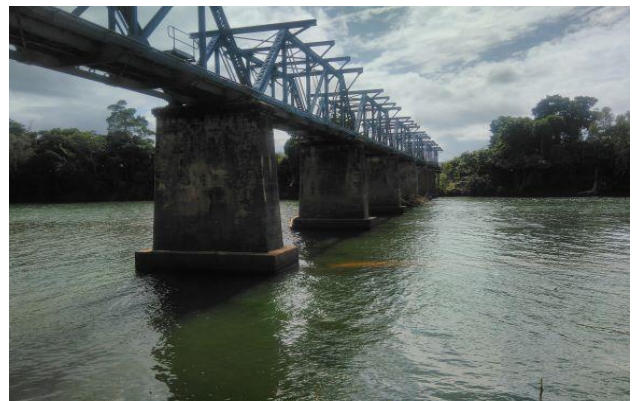
Over time, washouts along the riverbed had compromised the integrity of the piers. This, coupled with severe cracking on the unreinforced piers, meant that structural rehabilitation and strengthening was urgently required.

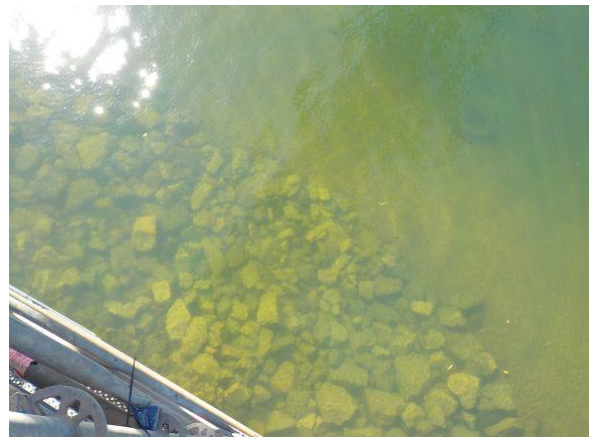
*Below: Some of the rock placed adjacent to the piers*

Depth readings were taken from a smaller vessel to ensure that the rock layer was the correct thickness. The rock encased the piers bases to protect them from further scour.

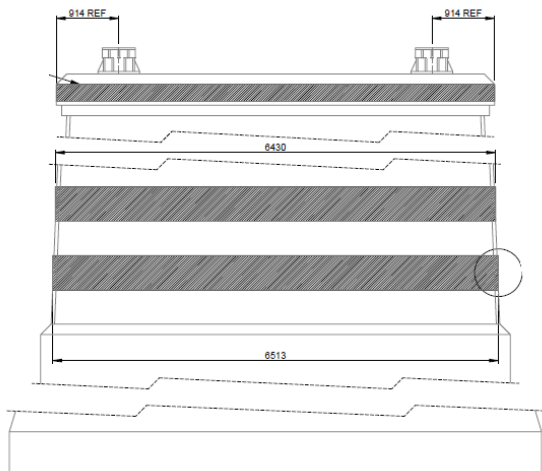
Below: The optimised design. The hatched bands represent 250mm and 500mm CFRP wrap. A heavy wrap of 600g/m<sup>2</sup> was used.

Dynaciv collaborated with a design consultant to optimise the proposed carbon fibre system that would strengthen the piers. The design consultant furthered the concept and completed the design. The new design from this joint working approach provided an innovative solution with added strengthening benefits.

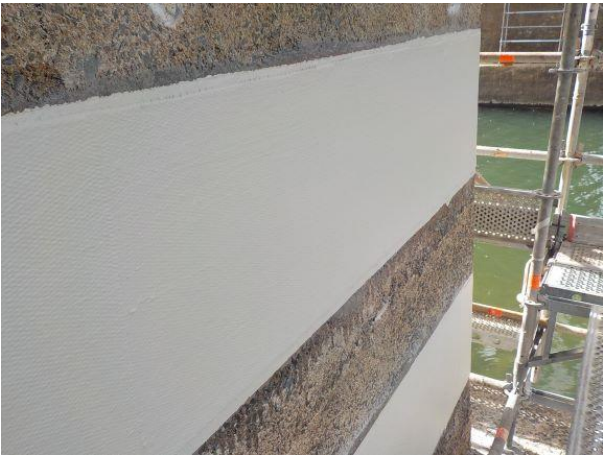
*Below: UV coating applied*

The bands were later coated with a UV protective coating.

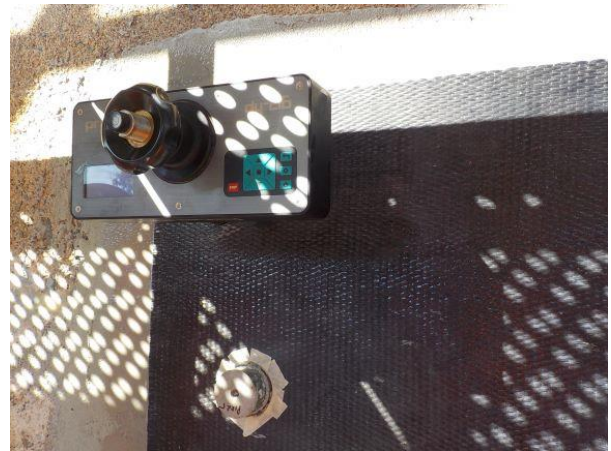
*Below: CFRP adhesion test*
