SPRINGFIELD RESERVOIR REMEDIATION

SPRINGFIELD 20ML RESERVOIR

Springfield College Drive Reservoir (R091) is a 20ML concrete reservoir located on Springfield College Drive, Ipswich. The reservoir was constructed circa 1996 and is a circular, post-tensioned concrete reservoir with an aluminium roof structure. The reservoir is 48m in diameter and has a depth of 10.98m.

Dynaciv was engaged by Queensland Urban Utilities to carry out reservoir rehabilitation including a new access ladder and staircase.

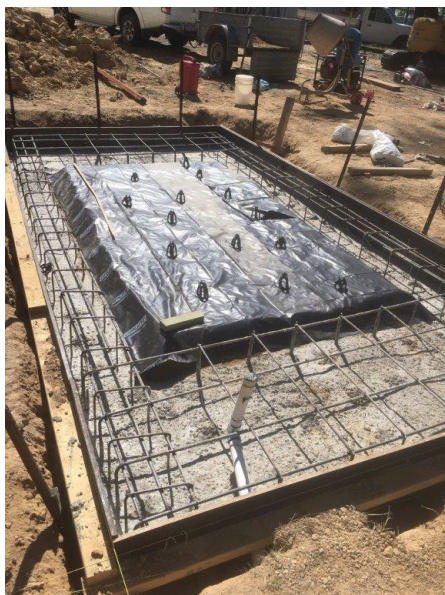
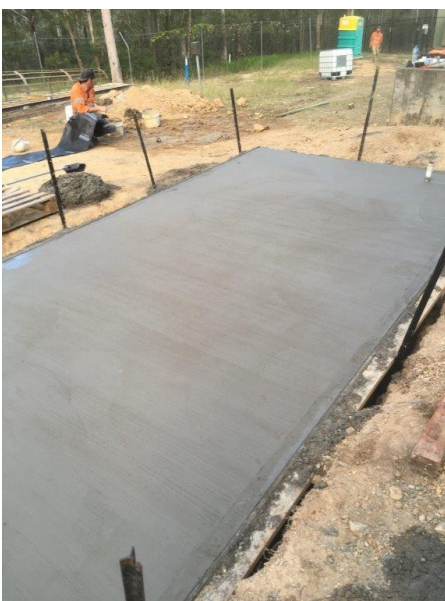
Following design and soil testing, the foundation installed as shown below.

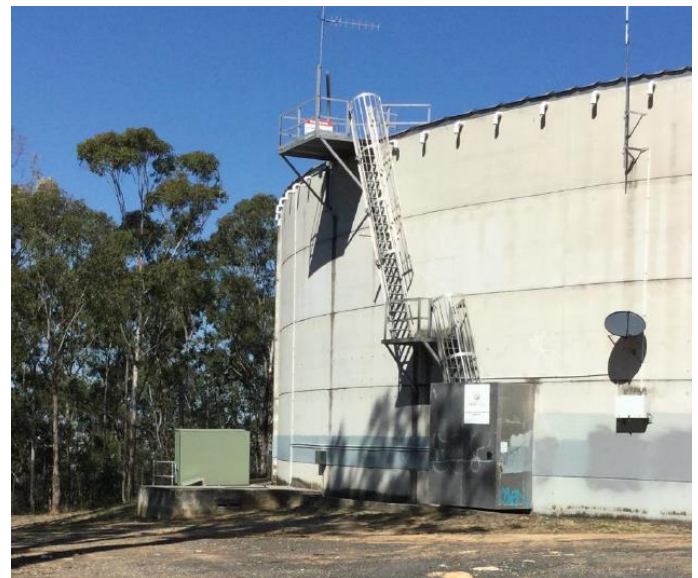
The previous staircase consisted of an inclined caged aluminium ladder. This ladder had to be replaced to comply with QUU’s current access requirements, a new foundation cast and the new steel case erected.

Existing staircase before removal

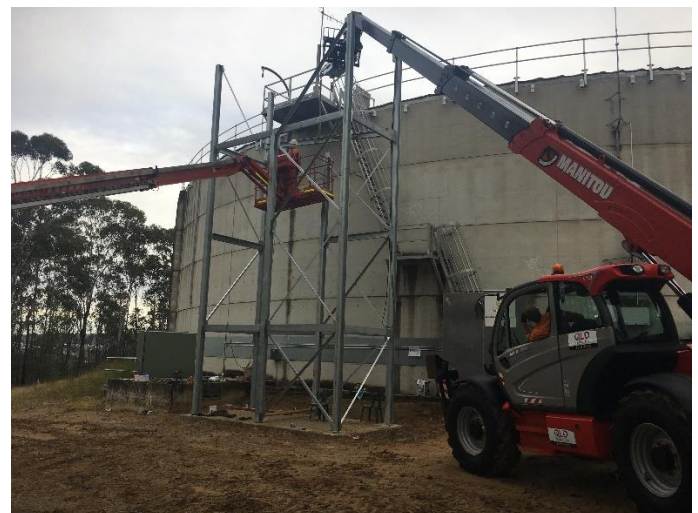
New staircase installation

The new steel staircase comprised of three landings. It measured 10 metres in height and the lower two thirds were encased in security mesh.

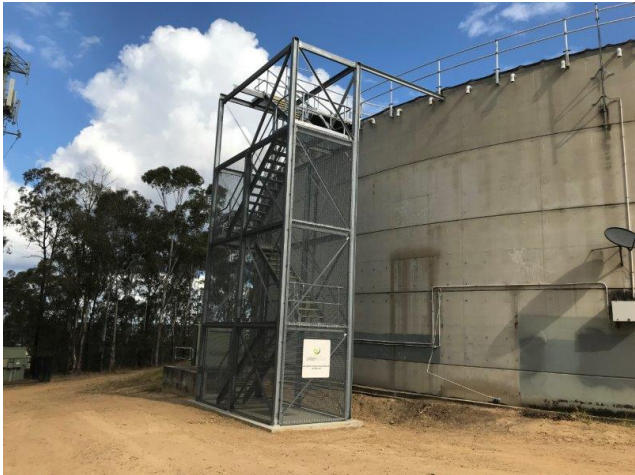
New staircase after installation

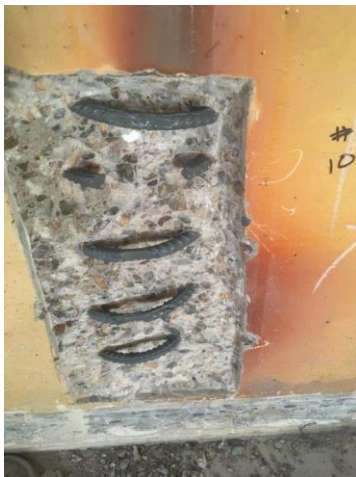
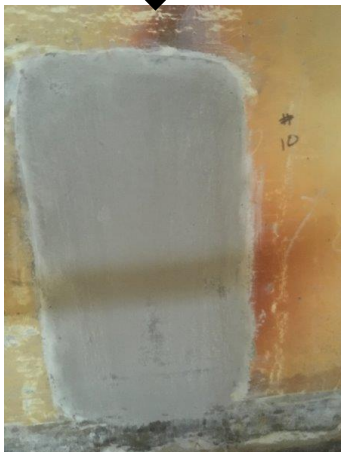
The concrete walls had a large number of defects where the reinforcing was corroding. The photos below illustrate a typical repair.

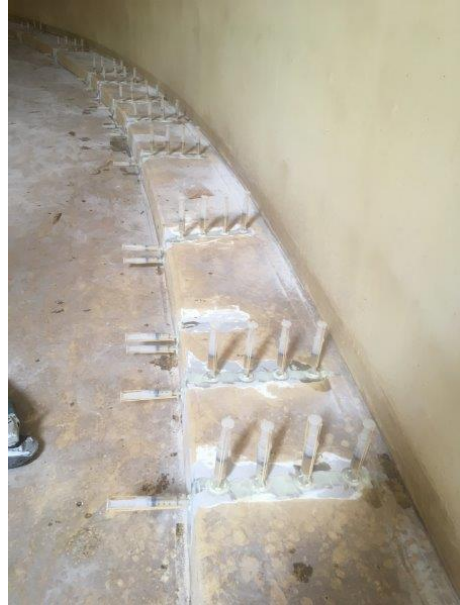
Crack injection

The structural ring beam had suffered severe cracking. This was repaired by adopting a low-pressure crack injection method to inject epoxy.

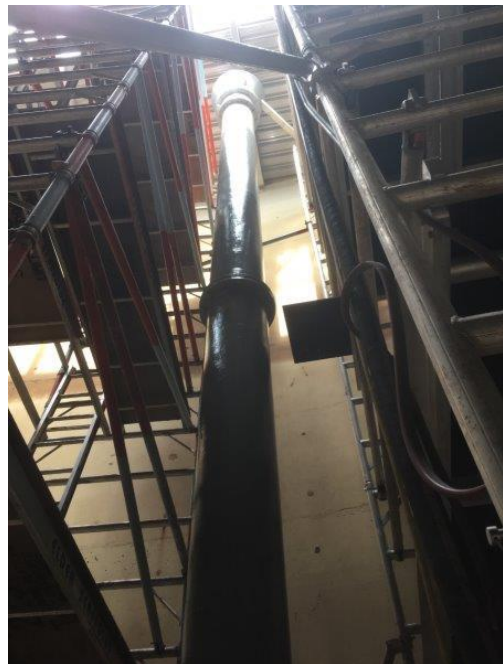
The overflow pipe required a new AS4020 coating. The previous coating had to be removed by sandblasting to achieve a defined surface profile and finish. The pipe was coated with three epoxy coats.

Access to overflow pipe

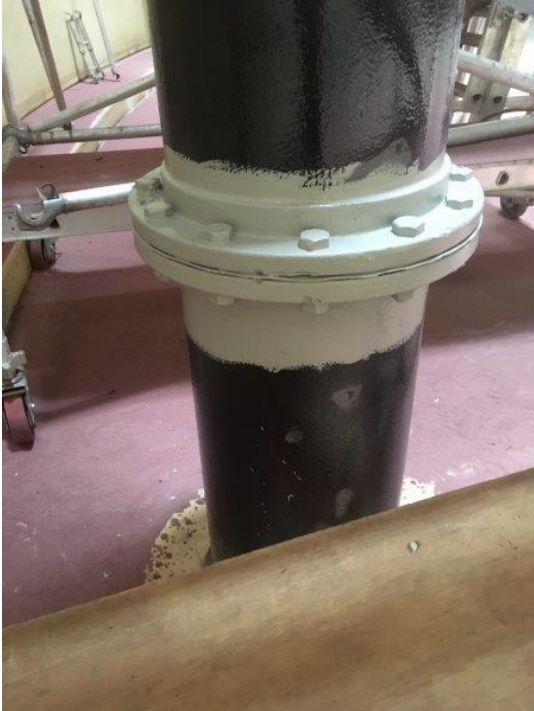
A typical stripe coat

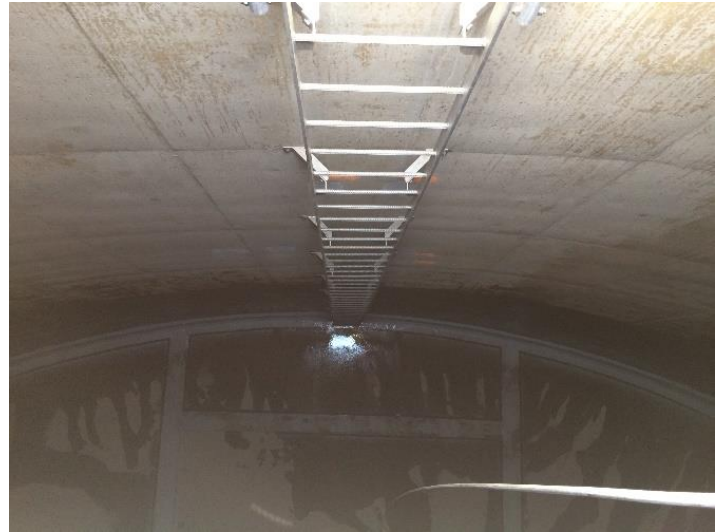
Stainless steel access ladder

A316 stainless steel ladder was designed, fabricated, and installed at the hatch.

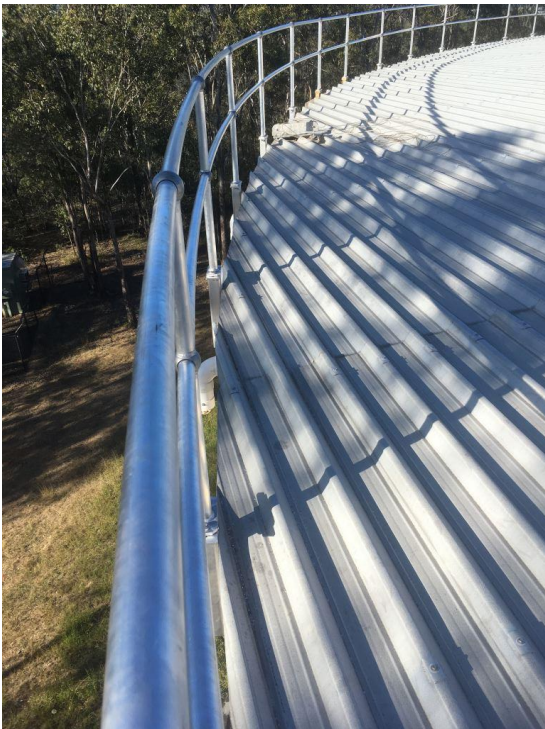
Railing along roof edge

Following the design and fabrication process, we erected in excess of 150m of aluminium railing.

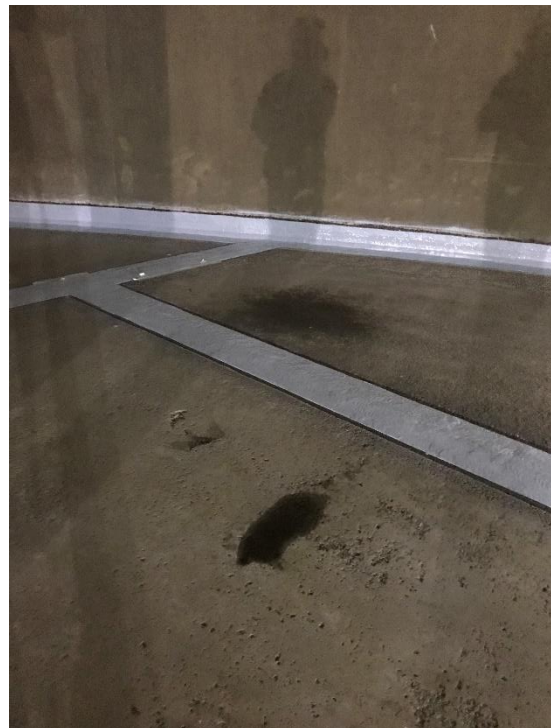
Rehabilitated joints

After joints were cleaned and sealed, they were waterproofed with a polyurea bandage.
