PROJECT SHEET

CFRP STRENGTHENING – 3 BRIDGES

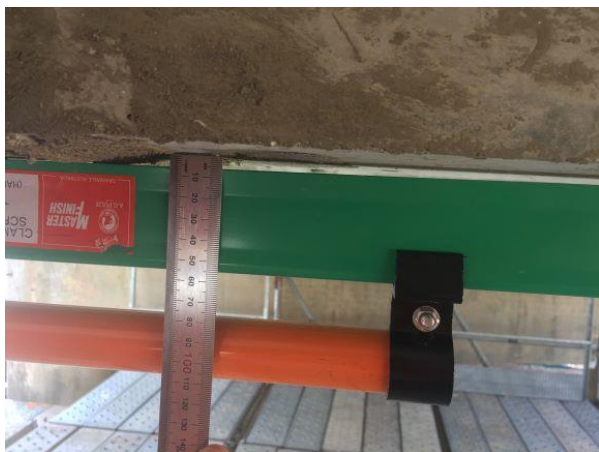
Above: A typical diaphragm where the deflection on the surface was in excess of the minimum 5mm allowance. The diaphragms required a significant amount of profiling.

All three bridges required a form of concrete repair and profiling prior to the application of CFRP. It is a general requirement for CFRP to be applied to an even surface.
