PROJECT SHEET

KURANDA STATION TURNTABLE

Client: Queensland Rail

Location: Kuranda

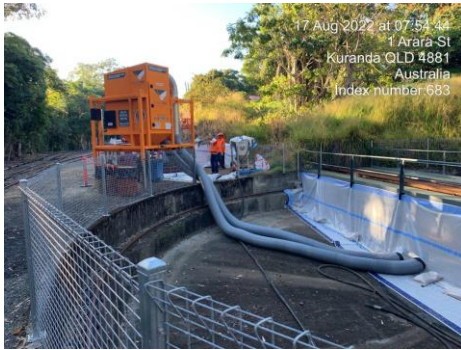
Due to the location of the job and high levels of lead in the coating, a 6,000 CFM dust extractor was used to extract dust from the encapsulated area.

6000 cfm Dust collector and encapsulation

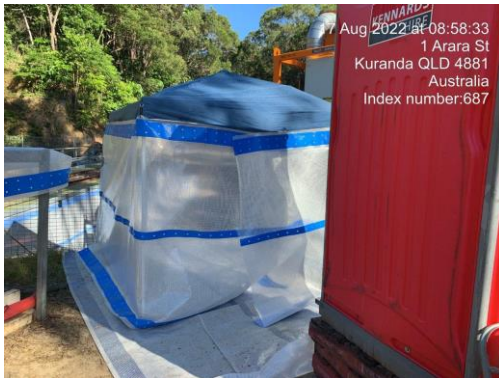
A containment area with shower was erected to ensure that no contamination left the area.

Enclosed change area and shower

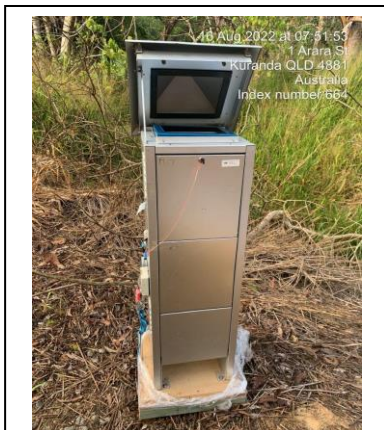
Air monitoring was critical and thus a sensitive air flow monitor was strategically setup near the work area.

High flow air monitor

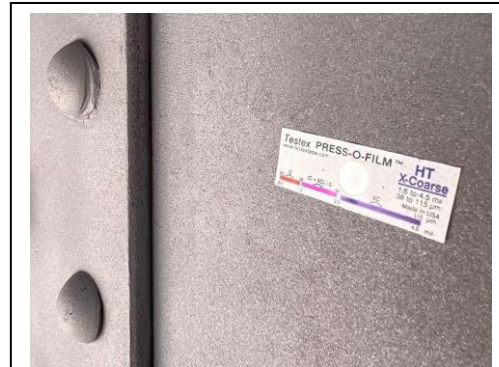
Blast Profile Testing

The contaminated coating was fully removed, and all hazardous waste correctly disposed of. A three-coat epoxy system was successfully applied to extend the life of this heritage listed asset. See testing photos below:

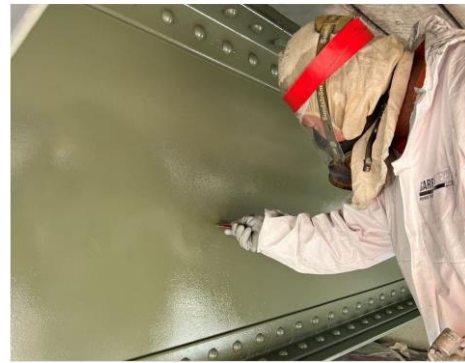
Wet Film Testing

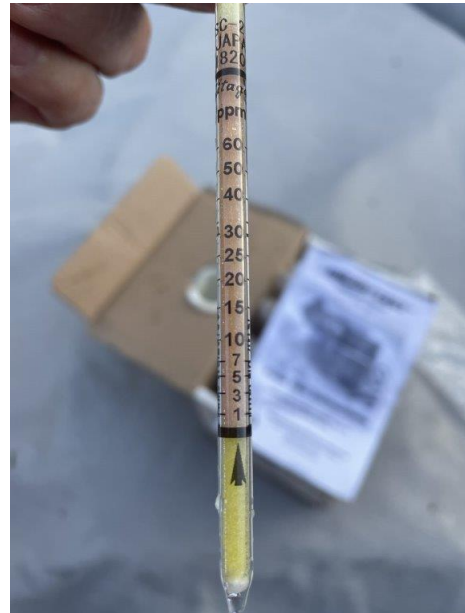
Salt Testing
