PROJECT SHEET

QR CULVERT STRENGTHENING AND REPAIR

Client: Queensland Rail

Location: South East Queensland

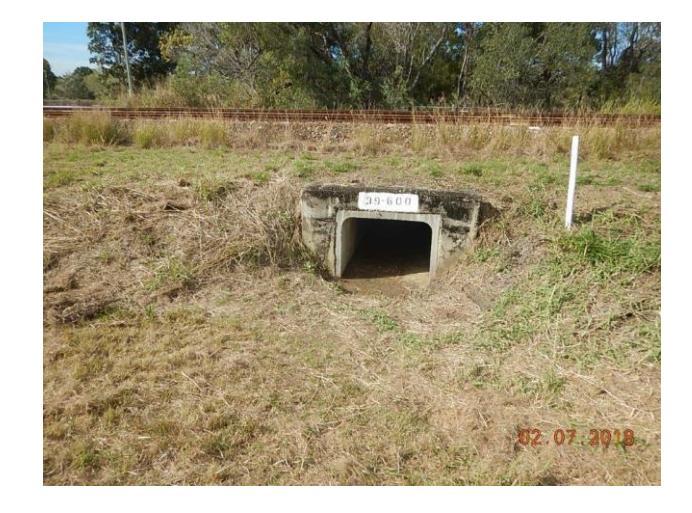
Some precast box culverts had deteriorated to a point where new ones had to be built inside the existing culvert to replace the structure. All works were completed within confined space. The culverts are assessed for safe entry prior to the development of strengthening design.
