# PROJECT SHEET

## AYR BRIDGES BEARING REHABILITATION

**Client:** Queensland Rail

**Location:** Ayr

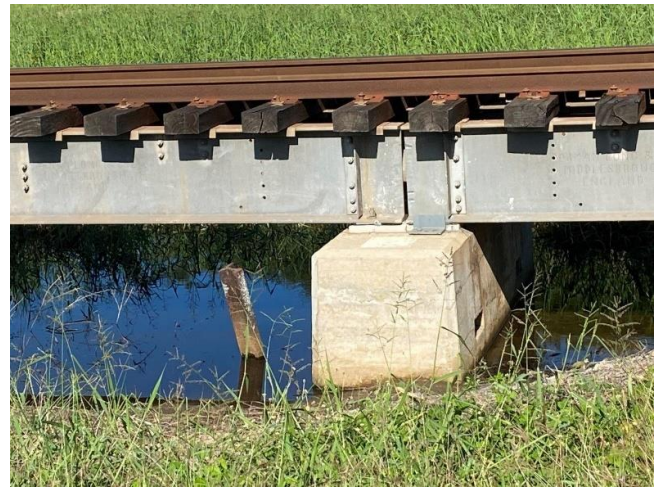
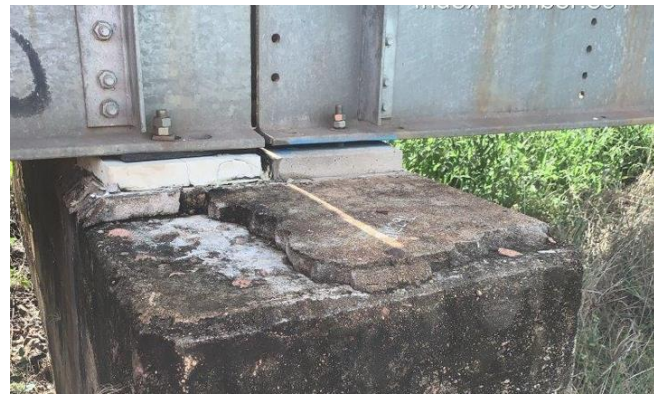
Typical work site and existing bearing

The existing bearings were damaged in many places which resulted in broken holding down bolts and cracked diaphragms. Queensland Rail initiated a new bearing design that is more robust to provide the girder more support and reduce the uneven loads on the diaphragms.

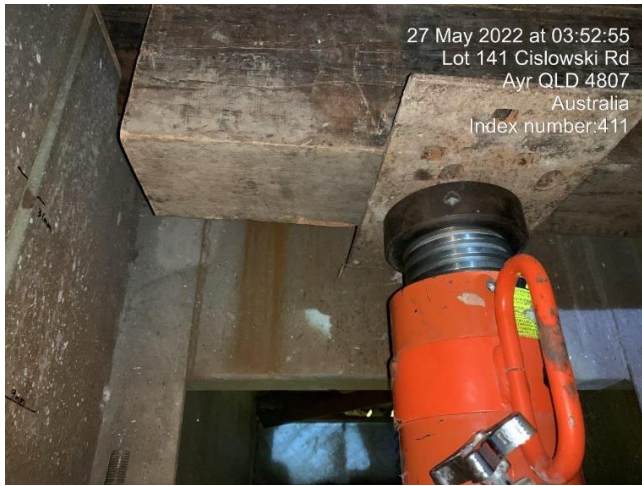
### Typical installed 55t jack

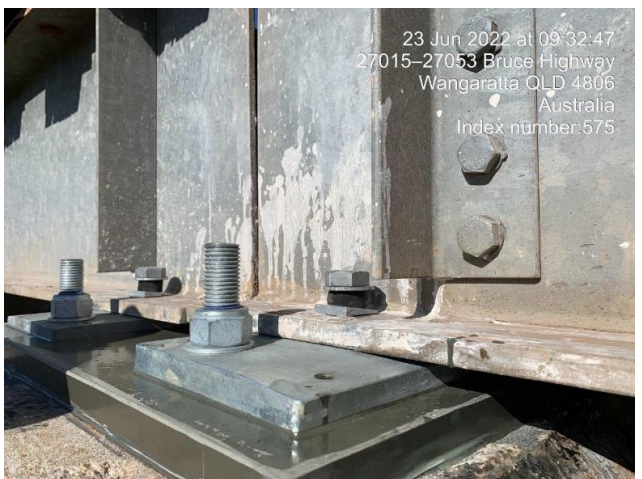
### Installed bearing

Dynaciv installed all 78 bearings successfully during closures and in between trains. Most of the bearing install was done during the night.

Most of the closures were only 8 hrs. We had to allow enough time for the grout to reach sufficient strength to allow trains to pass.

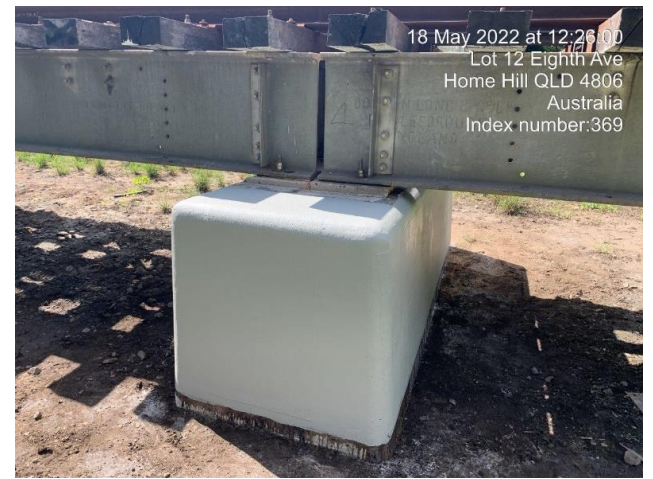
### Completed CFRP wrap
