DYNACIV PTY LTD

SEALING OF GAS BORES

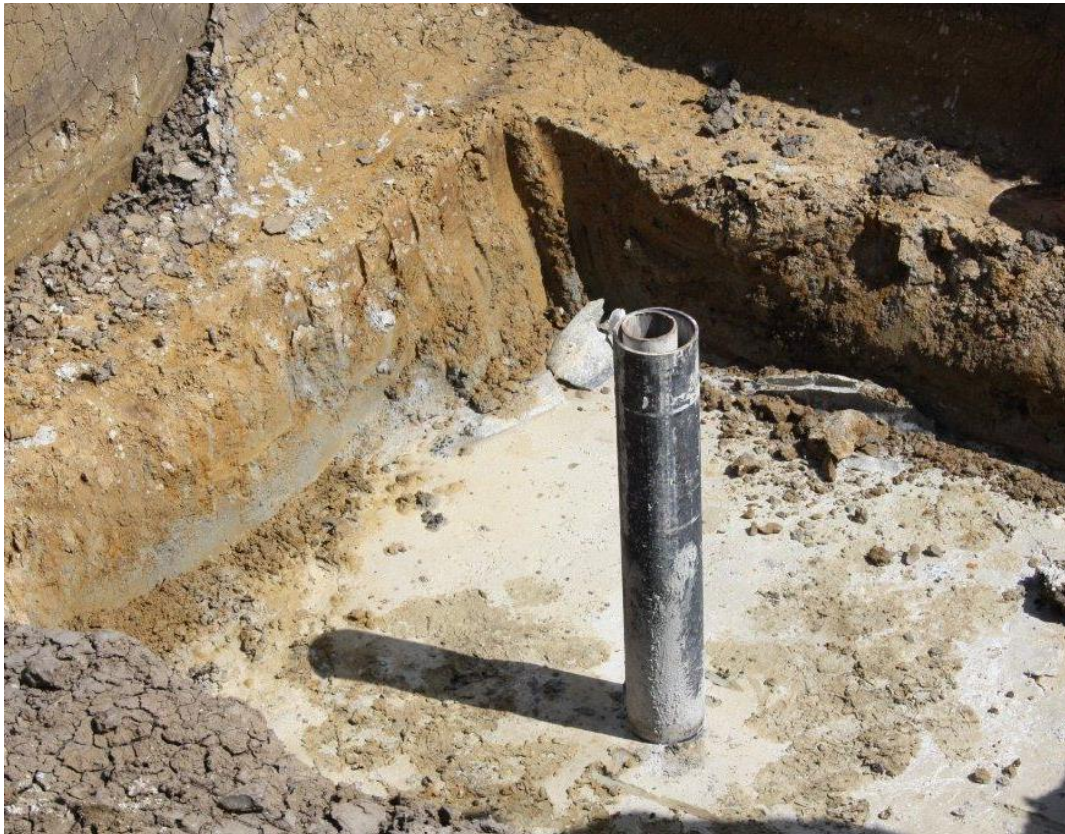
Top of the leaking gas bore

The drill site area was scheduled for rehabilitation a few weeks after the concreting. However, at the commencement of the rehabilitation, a gas emission was noticed at one of the bores. After conducting several tests, it was determined that methane was escaping from the bores. The source of the gas could not be identified, but one of two discrete gas reservoirs was thought to be the source.

An in-depth investigation yielded sufficient evidence to attribute the gas emissions to micro-channels between the cementitious plug and the bore lining.

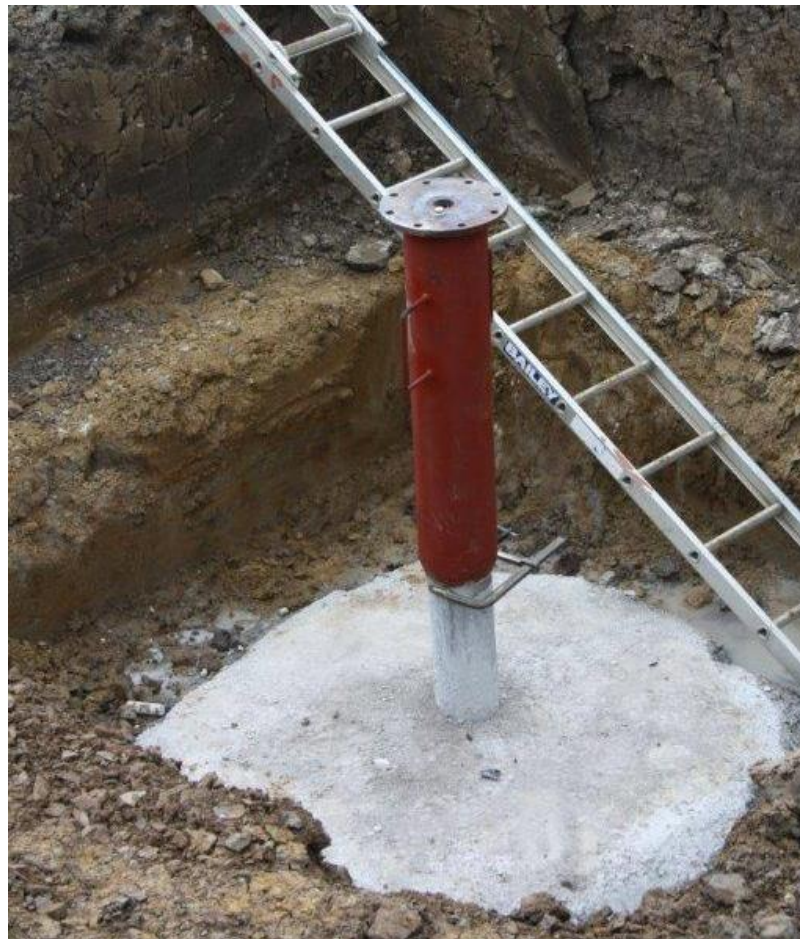
Well collar before welding

The proposed solution required the bore to be cleaned out/drilled to a depth of 1 m below the surface. This would provide an adequate bond area for the epoxy seal.

A pre-manufactured steel collar and cap fitted with an air coupling was welded onto the bore as shown in the picture below.

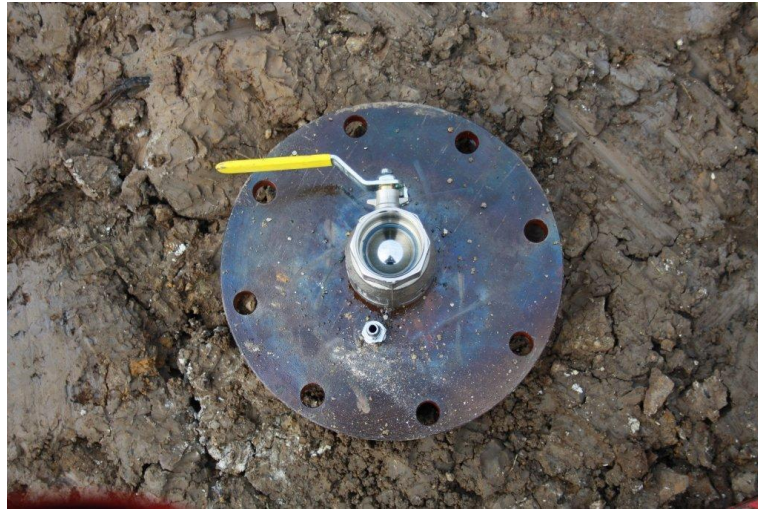
Collar cap with closed valve and air inlet

The collar was then filled with a formulated adhesive epoxy. This special blend produced by Dynaciv is formulated to maximise adhesion and generate low exothermic heat. Once filled, the valve was closed, and the collar pressurised to 500 kPa.

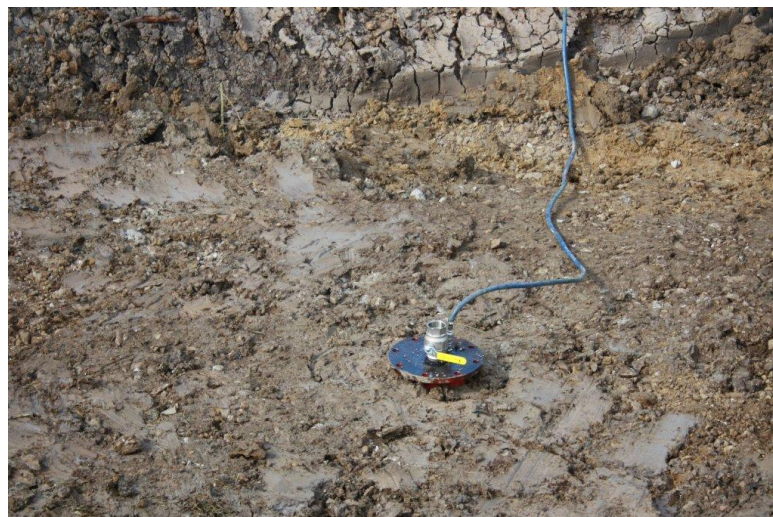
Collar cap, closed valve and airline

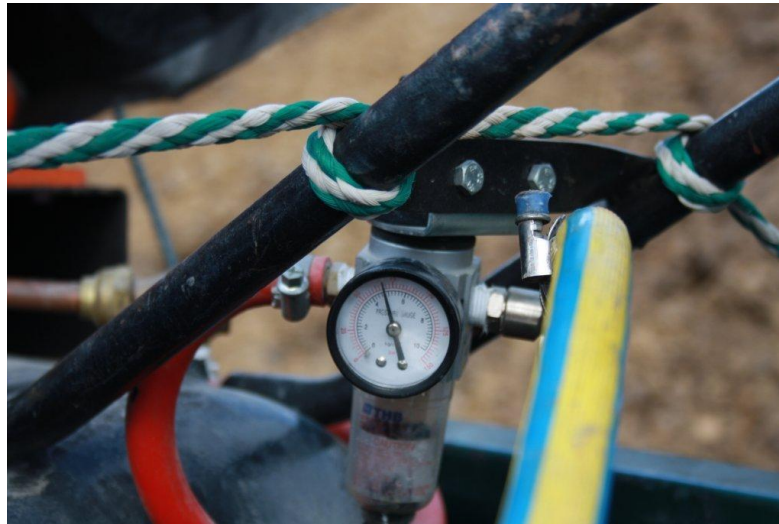
Pressure of the vessel

The pressurised collar was allowed to stand for 24 hours while the epoxy cured. The air pressure would force the epoxy into the micro-channels through which the gas was leaking.

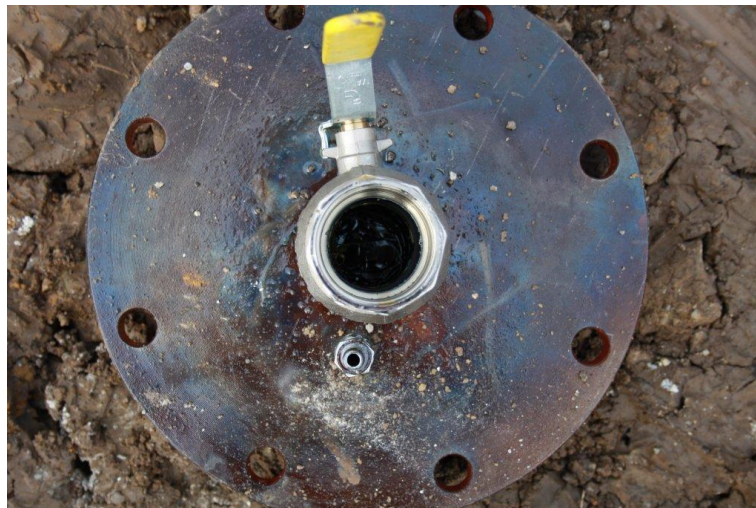
Collar cap, open valve and surface of the epoxy

After 24 hours, the pressure was slowly released from the collar. Once the collar was completely depressurised, the valve was opened to inspect the epoxy. A gas monitor was used to detect any leaking gas.

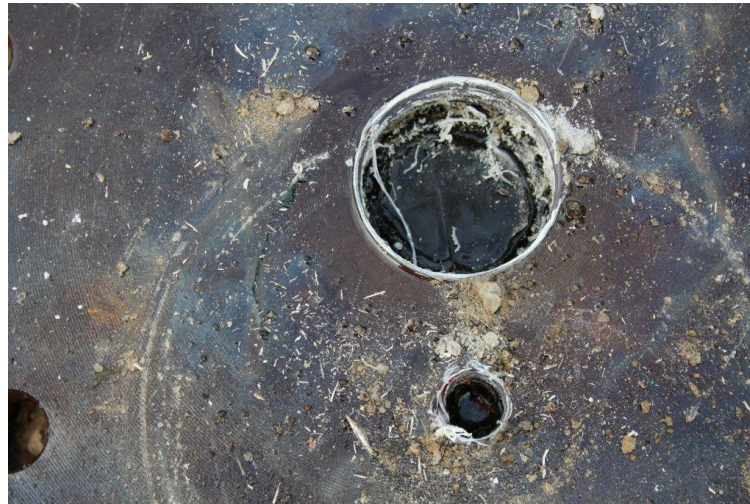
Close-up of the collar cap with the valve and air inlet removed

(Notice that the collar is now filled with epoxy)

If the level of the epoxy had dropped significantly during the pressurising process, the procedure would have been repeated until the epoxy maintained its level.

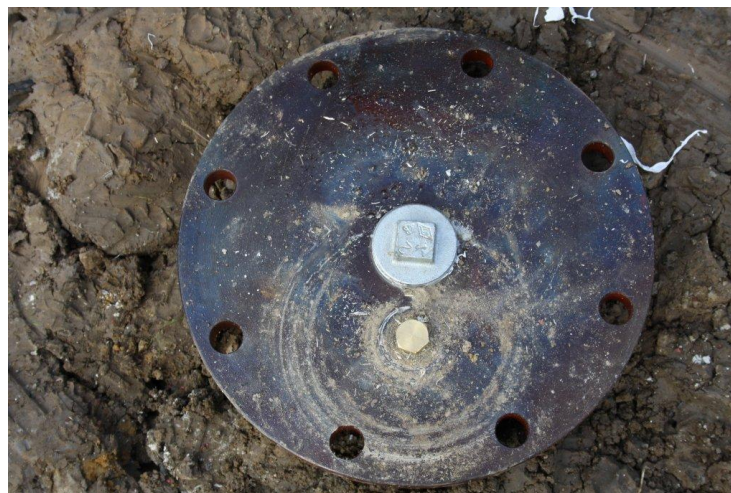
Closed bore cap

After the valve and air inlet were removed, the epoxy was topped up and the screw-on plugs were fastened.
