EILDON HILL RESERVOIR

PROJECT SUMMARY

Client: Queensland Urban Utilities

Location: Windsor, North Brisbane

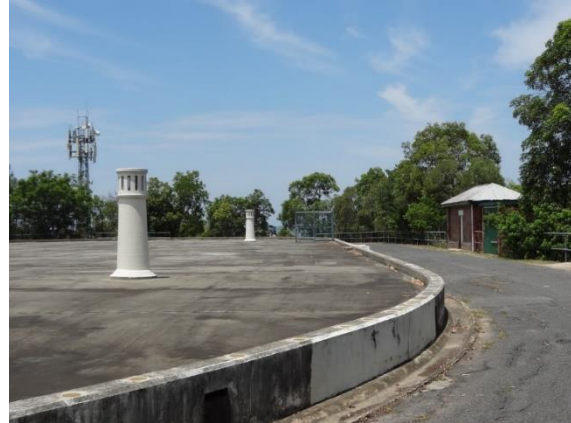
A significant internal and external rehabilitation project was undertaken in 2010 to extend the life of Eildon Hill Reservoir. The internal works consisted of repairs to the soffit of the reinforced concrete reservoir roof, reinforced concrete columns, column capitals, wall monoliths and floor joints. A post project inspection inside the reservoir was carried out in July 2012 and the inspection revealed failure of a number of the roof slab joint repairs (on the underside of the

joint) leading to exposure of reinforcement at some locations. This project was to repair previous failed repairs and any structural defects.

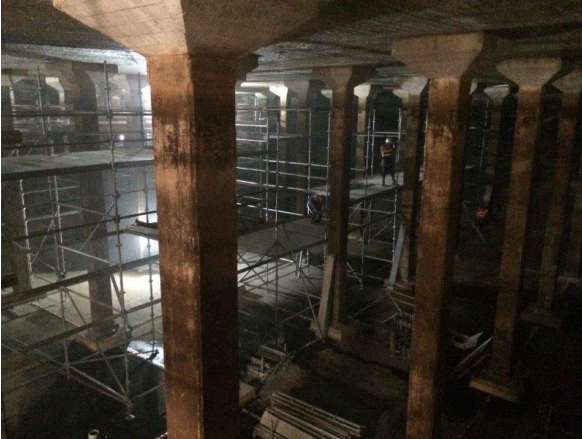
Scaffold platforms were erected to install 650m of new expansion joints.

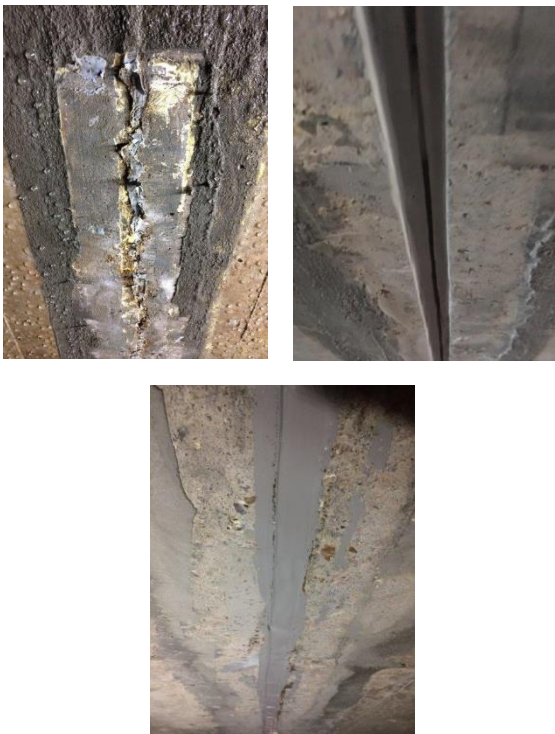
Repair of construction joints (New expansion joints):

Expansion joints were cut out along the existing constructions joints and joint edges and corroded rebar replaced to create a new strong edge for the new expansion joints

Photos above show construction joints cut out and repaired with epoxy paste and filled with joint sealant.

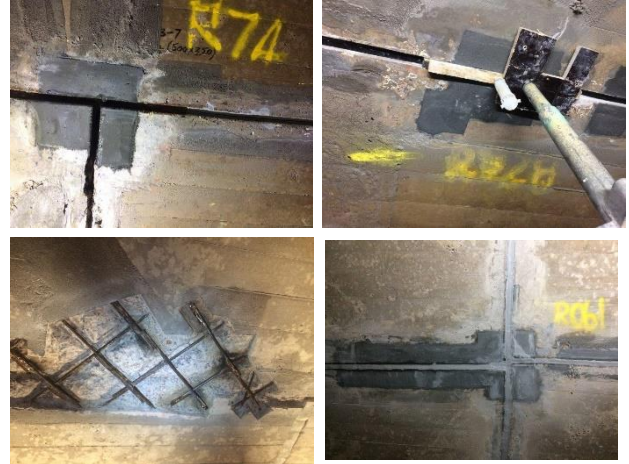
Joint Concrete Repairs

Photos above show repairs along the new expansion joints, corroded reinforcement bars replaced, voids in new expansion joints injected with a polyurethane and joints filled with joint sealant.

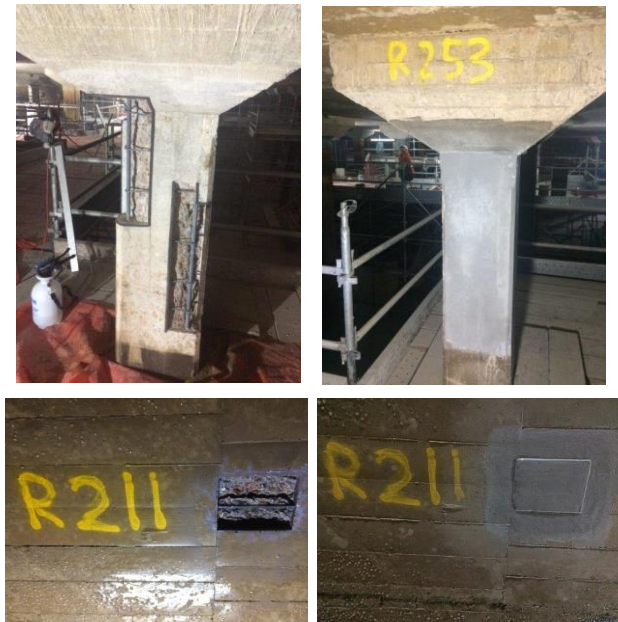
Column and Soffit Repairs

Photos above show some of the column and soffit repairs.

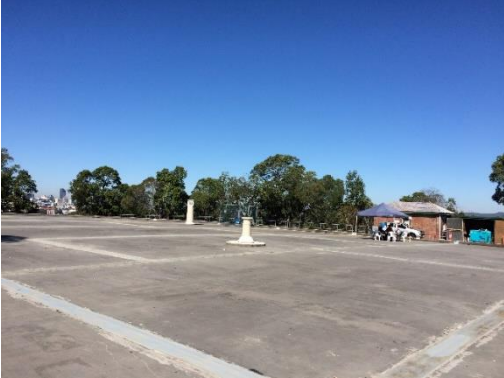
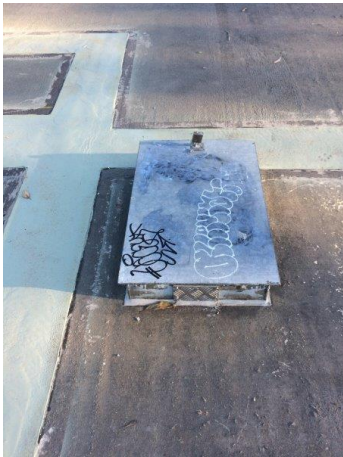
Application of the polyurea membrane

The 650m roof joints were prepared by diamond grinding, primed and sprayed with a 4.6mm thick pure polyurea membrane.
