# PROJECT SHEET

## CULVERT STRUCTURAL REMEDIATION

### Culvert C2010 (Southbound)

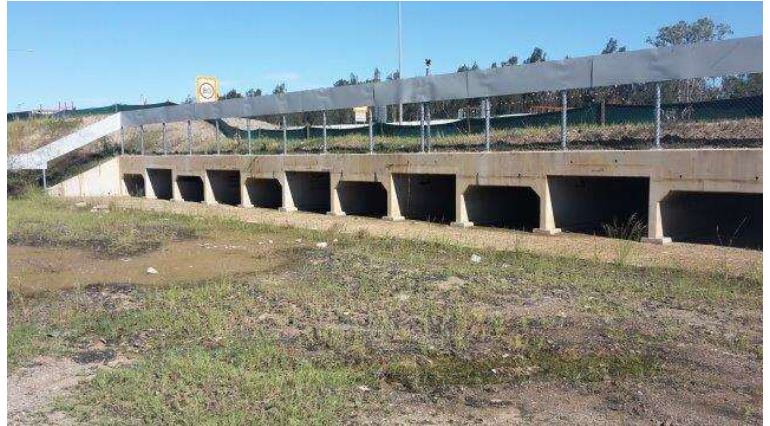
The following works were completed at Culverts C2010 (15 cells), C2009 (16 cells) and C2008 (6 cells) in 2016:

- Spalling repairs: 294 in total
- Replaced corroded bars (sections exceeding 20% loss): 48m
- Crack repair: 360m
- Waterproof coating:(Vandex Concrete Grey): 950m<sup>2</sup>
- Pressure washing: 950m<sup>2</sup>
