# GROVELY RESERVOIR

## PROJECT SUMMARY

## GROVELY RESERVOIR – NORTH SIDE

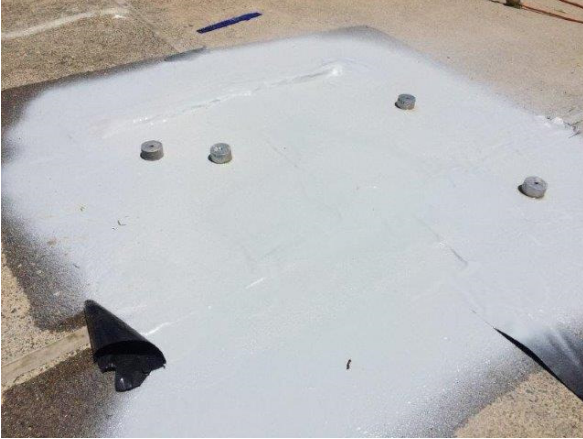
### Test Panel:

A test panel was first done and tested using Epoxy Solutions equipment. The aim of the test work was to determine bond strengths and test various bond breaking systems.

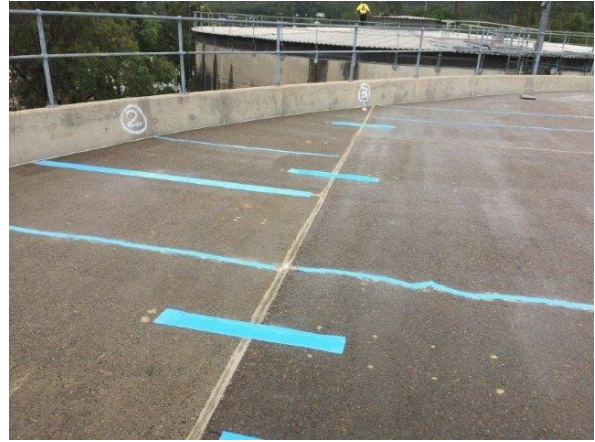
### Protection of joint straps

The roof slabs have jointing straps which need to be covered to avoid punching of the membrane

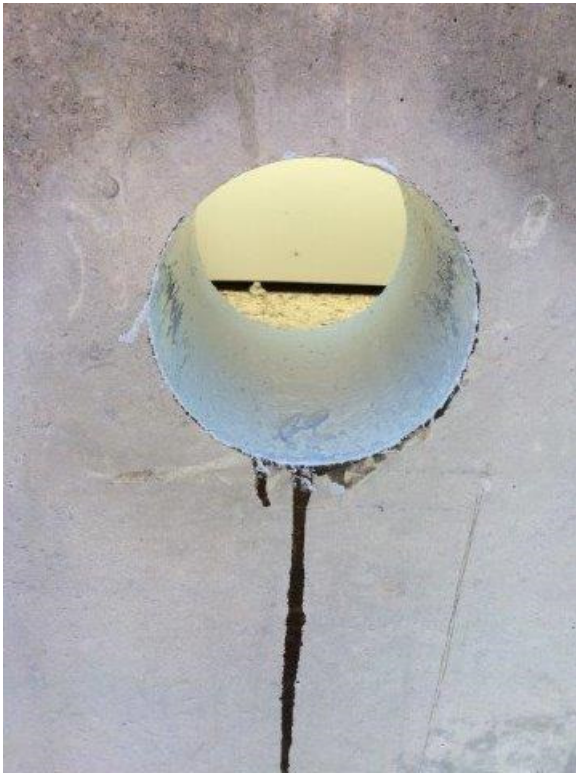
### Core drilling drain holes

The existing drainage was thought to be insufficient. Epoxy Solutions cored new drain holes which were epoxy coated to protect the reinforcing.

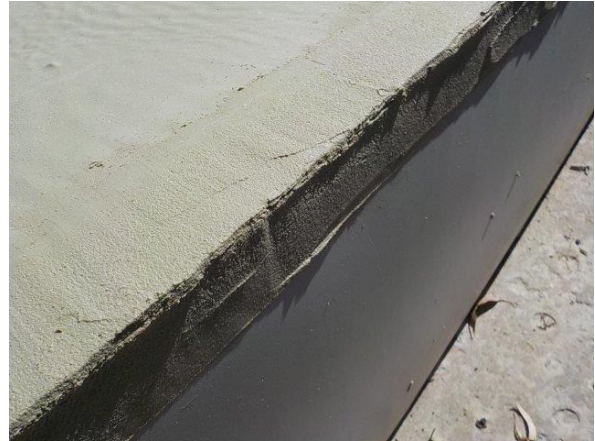
### Installation of rubber flashing

It was thought that dirty water may entering the reservoir through roof run-off past the vermin proofing. Epoxy Solutions installed a UV resistant rubber flashing to direct run-off past the vermin proofing
