# PROJECT SHEET

## LEGACY WAY TUNNEL

#### LEGACY WAY TUNNEL 2015

Legacy Way Tunnel is a 4.6-kilometre-long tunnel joining the Western Freeway at Toowong to the Inner-City Bypass at Kelvin Grove. Construction started mid-2012 and it was opened on 25 June 2015. Legacy Way was named to honour the men and women of the Australian Defence Force.

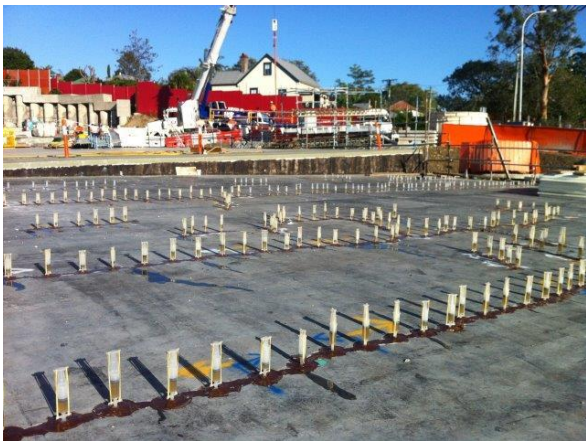
Various types of cracks were repaired using a range of methods. Quality checks were performed through destructive testing. Our attention to detail and methodical task completion led to almost 10km of successful crack injection.

*Below: Low pressure injection in a slab.*

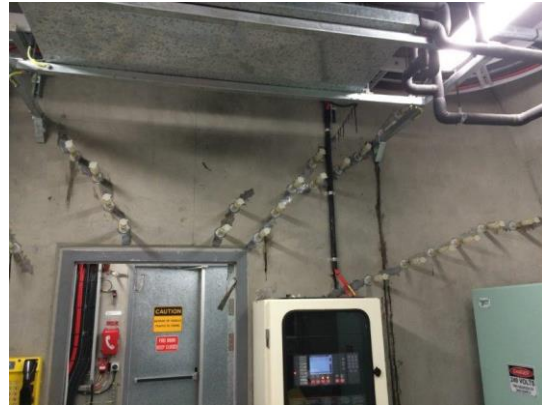
*Below: Low-pressure injection in the tunnel*

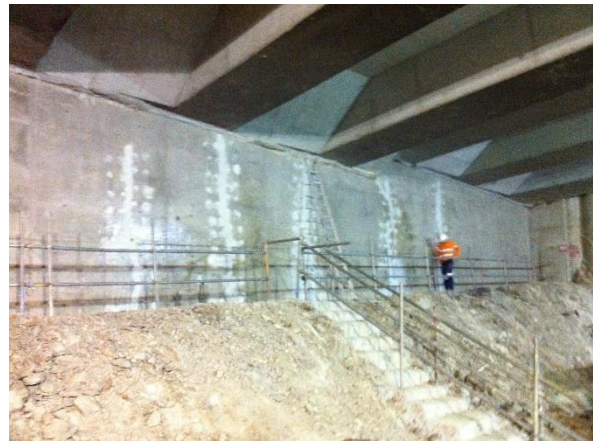
*Below: A deep beam below the ICB that was successfully injected using a range of methods, including high pressure.*

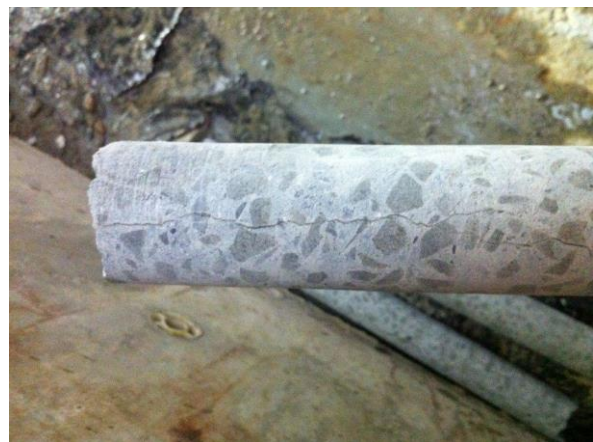
*Below: A core taken 1000 mm into the beam. Note the epoxy throughout the crack*

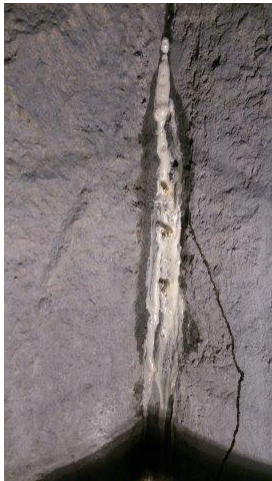
As most of the work was performed underground, groundwater was a common problem which had to be controlled. Dynaciv adopted a variety of methods to inject closed and open cell foam into problematic areas. This was often done to slow or stop water until a more permanent solution could be implemented.

*Above: Foam slowing water flow into the work site*

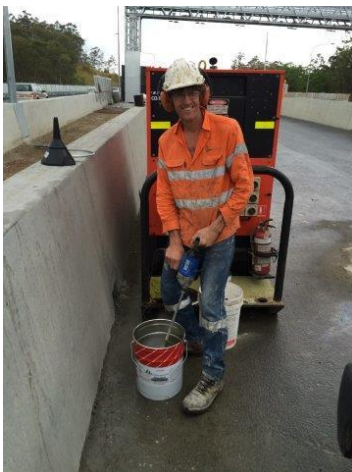
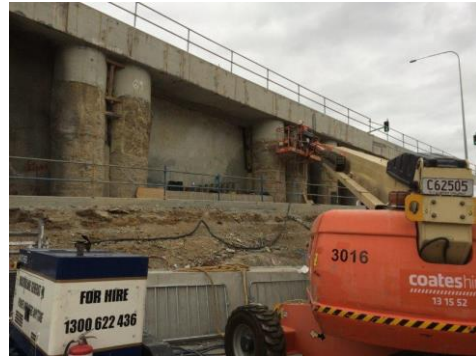
*Below: Concrete repairs at the entrance to the western portal.*

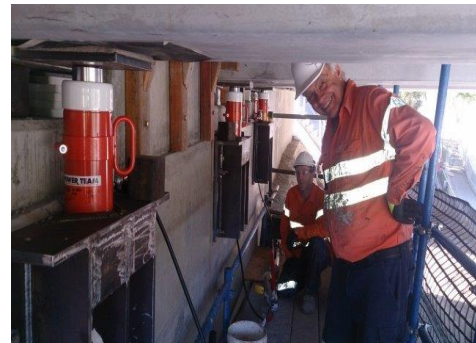
*Below: The Russell Terrace bridge that we lifted/jacked to install the bearing grout.*

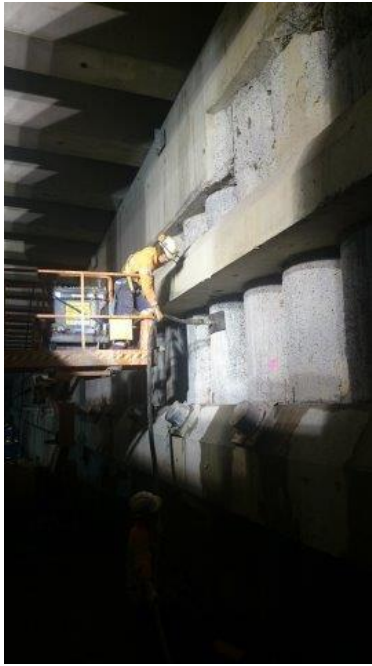
Our engineers worked closely with the designers and site engineers to solve many issues. One of these issues were the removal and grouting of temporary anchor strands. The photos below show some of this work. The challenge was to cut the strands about half a meter in the corbel while they were imbedded in a flammable substrate.

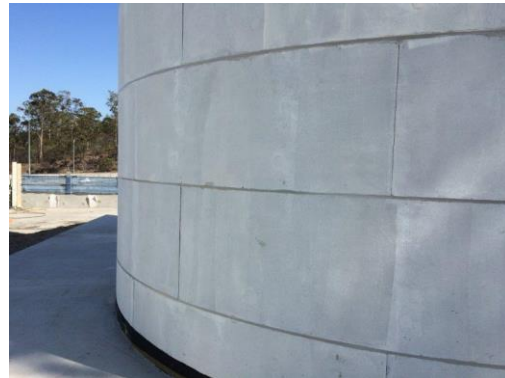
*Below: The lower rings of the vent stack with joint sealant.*

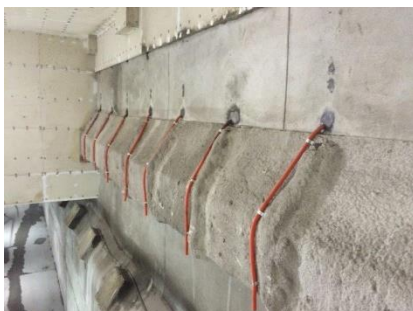
*Below: Completed drains*
