## LEGACY WAY TUNNEL

### PROJECT SUMMARY

#### LEGACY WAY TUNNEL 2015

Epoxy Solutions was commissioned to carry out defect repair work. After proving our capability and quality of work to the engineers at Transcity JV and the client, Brisbane City Council, Epoxy Solutions was asked to provide many structural remedial solutions to structures such as the remediation of the deep beam that supports the ICB above the Eastern Portal and the corbels supporting the corbel slab in both tunnels.

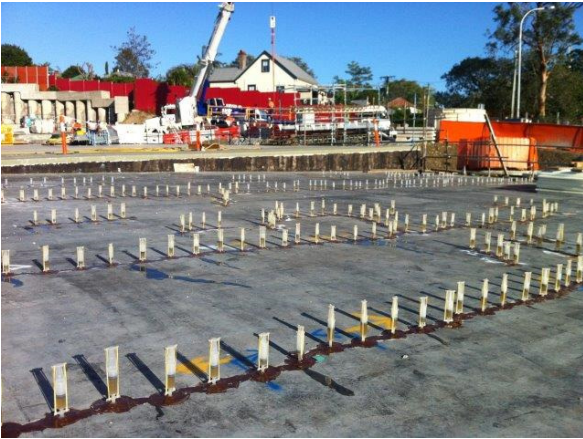
Various types of cracks were repaired using various methods. Quality checks were done through destructive testing. Our attention to detail and carrying out the tasks methodically, led to almost 10 Km of successful crack injection. The photo below shows low pressure injection in a slab.

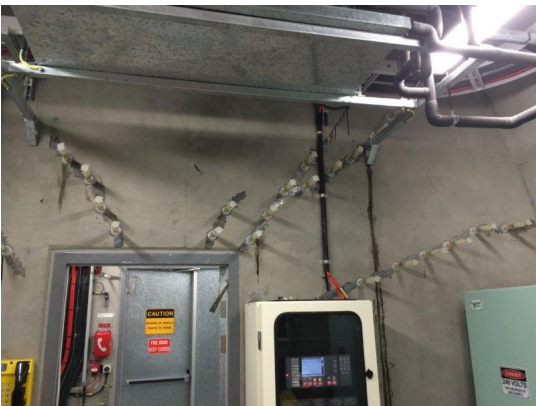
The photo below shows some low-pressure injection in the tunnel

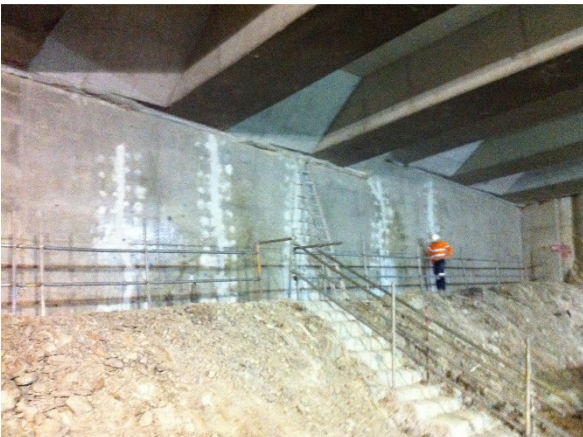
The photo below shows a deep beam below the ICB that was successfully injected using various methods, including high pressure.

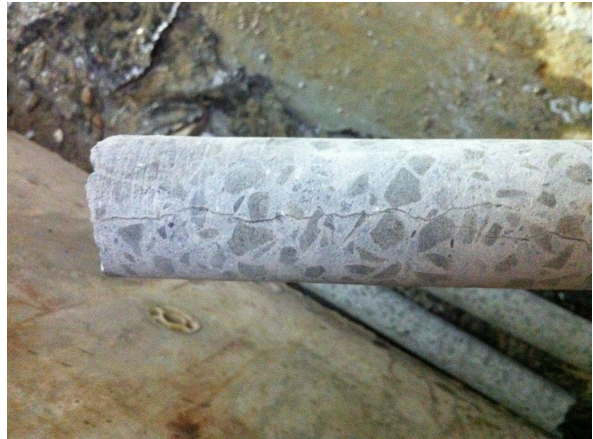
The photo below shows a core taken 1000 mm in the beam. Note the epoxy throughout the crack

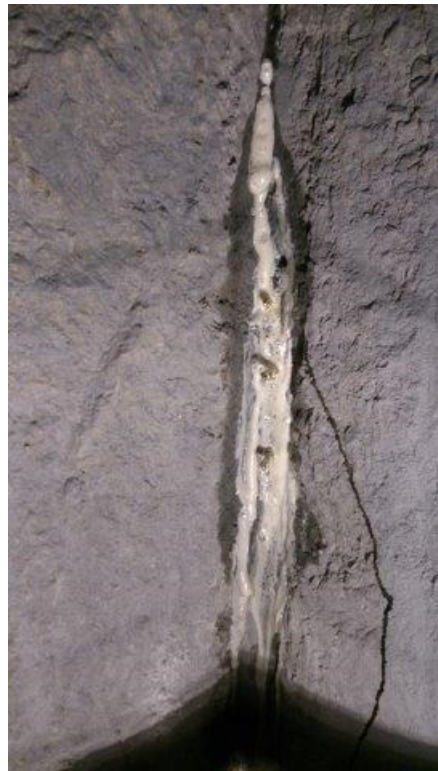
As most of the work was done underground, groundwater was a common problem that had to be managed. Epoxy Solutions adopted various methods to inject a closed and open cell foam in various places. This was often done to slow or stop water, so a more permanent solution could be implemented.

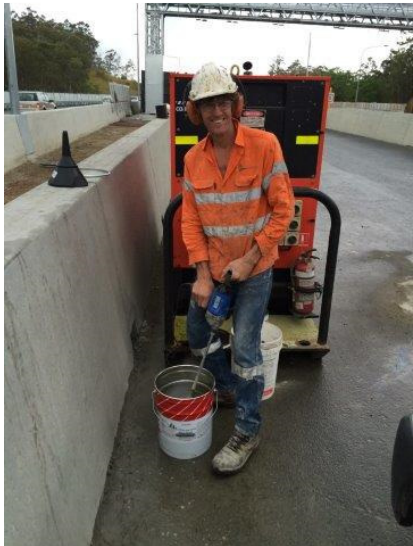
Work was also done on the surface in both portals, vent towers and other associated structures such as bridges. The photos below show concrete repairs done in the entrance to the western portal.

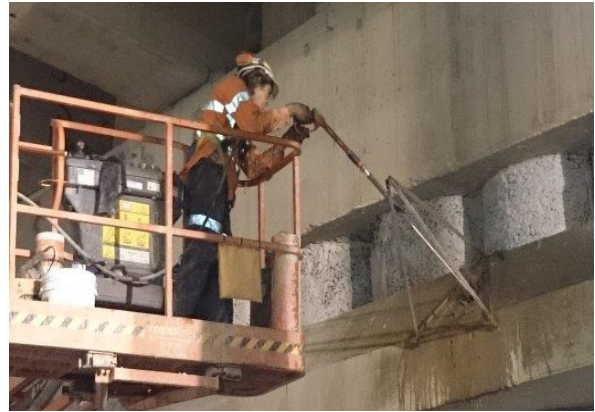
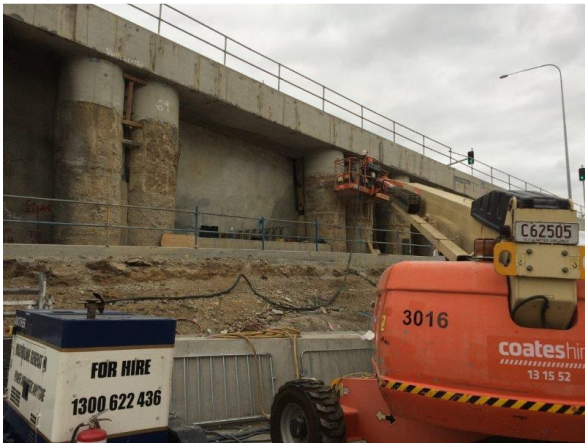
Our engineers worked closely with the designers and site engineers to solve many issues. One of these issues were the removal and grouting of temporary anchor strands. The photos below show some of this work. The challenging part was to cut the strands about half a meter in the corbel while the strands were imbedded in a flammable substrate.

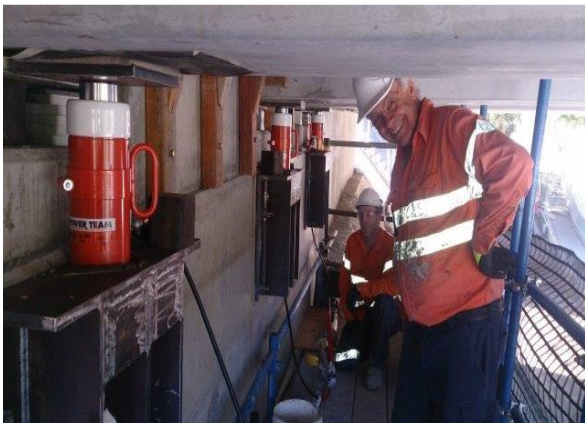
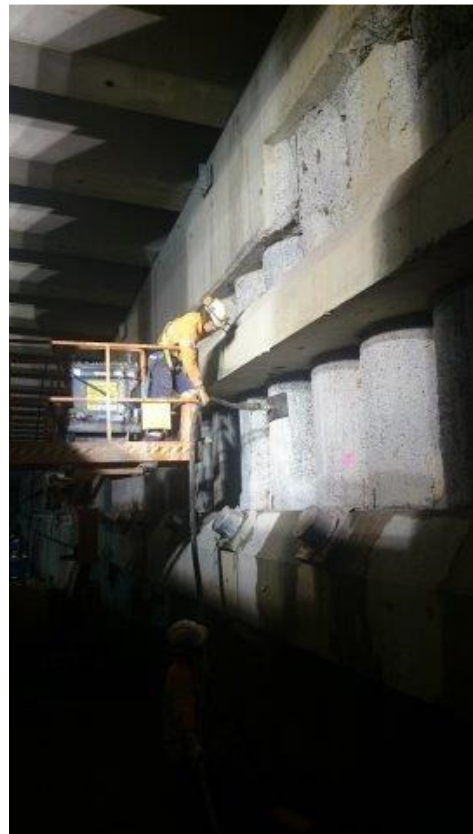
The photo below shows Russel Terrace bridge that we lifted/jacked to install the epoxy grout.

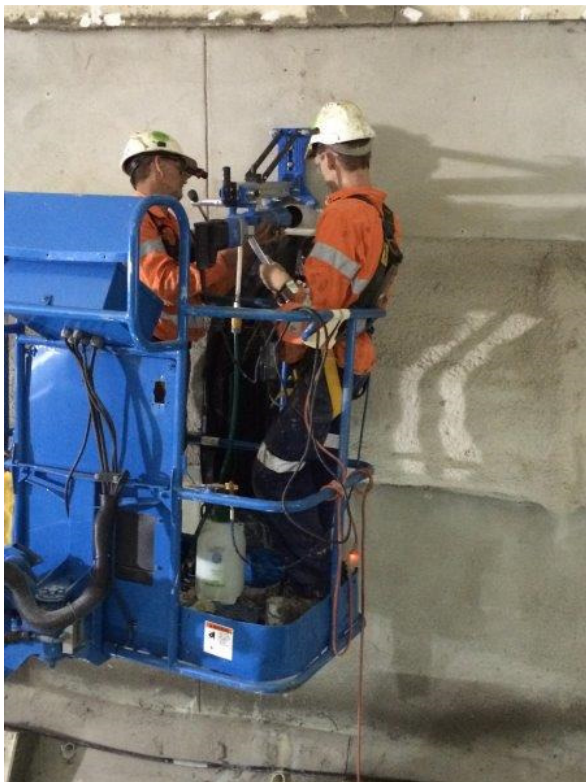
We also carried out core drilling to install new drains to assist in dewatering. The photos below show the coring and completed drains.

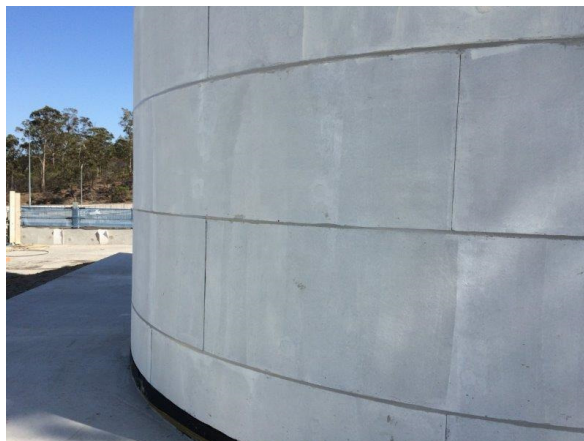
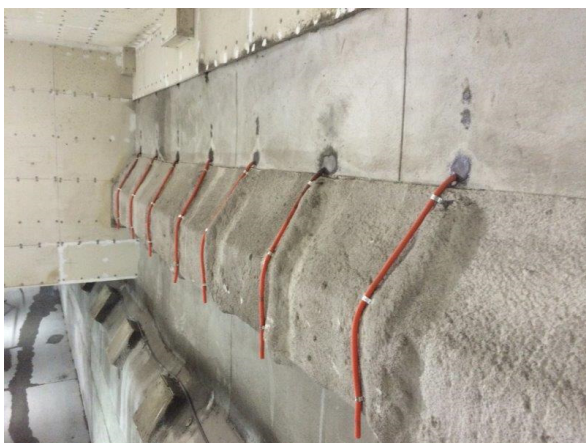
The photo below shows the lower rings of the Vent Stack with joint sealant.
