PROJECT SHEET

BILOELA RESERVOIR REMEDIATION

Client: Banana Shire Council

BILOELA 9ML RESERVOIR

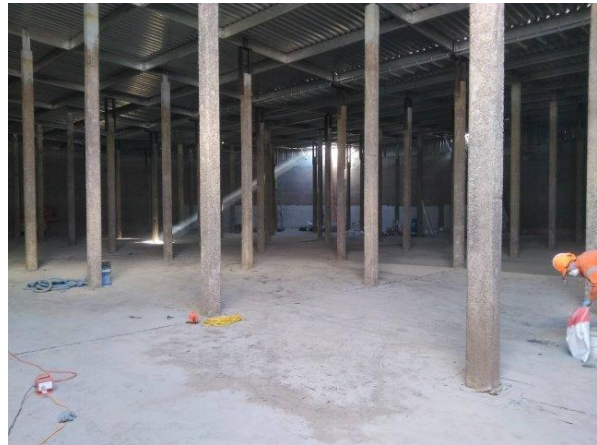
Banana Shire Council (BSC) engaged Epoxy Solutions to carry out the structural remediation and waterproofing of a 9ML reservoir. The Biloele Reservoir has an aluminium roof that is supported by 69 reinforced concrete columns. The reservoir was constructed in 1967 and required rehabilitation work to maintain its structural integrity and durability.

An independent structural condition assessment completed in early 2017 identified defects that required remediation for long and short-term operation. The defects ranged from minor surface repairs to large grout pours and reinforcing replacement.
