GATEWAY UPGRADE NORTH

PROJECT SUMMARY

Culvert C2010 (Southbound)

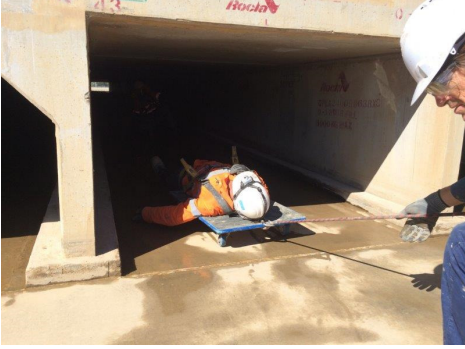
<p>Confined Space Access</p>  	<p>Confined Space Rescue</p>
