CHINCHILLA WATER TREATMENT PLANT (PROTECTIVE COATINGS)

PROJECT SUMMARY

New Chinchilla Water Treatment Plant Chemical bunds

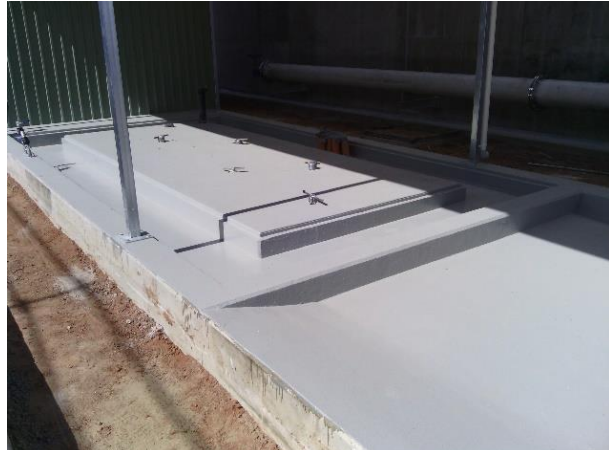
<p><u>Materials Used:</u></p> <ol style="list-style-type: none">1. Chemrite Epoxy Paste2. Chemrite Primer 813. Chemrite 135
<p><u>Chemical Room 2: Protective Coating in Chemical Bunds (PAC and Liquid Polymer)</u></p>

<p><u>Materials Used:</u></p> <ol style="list-style-type: none">1. Chemrite Epoxy Paste2. Chemrite Primer 813. Chemrite 135
<p><u>Water Clarification Tanks: Polyurethane joint sealing</u></p>
